The BOUSSOLE project technical reports; report #7-12, issue 1.

BOUSSOLE buoy deployment & maintenance log.

October 27, 2009 - April 22, 2010

BOUSSOLE project

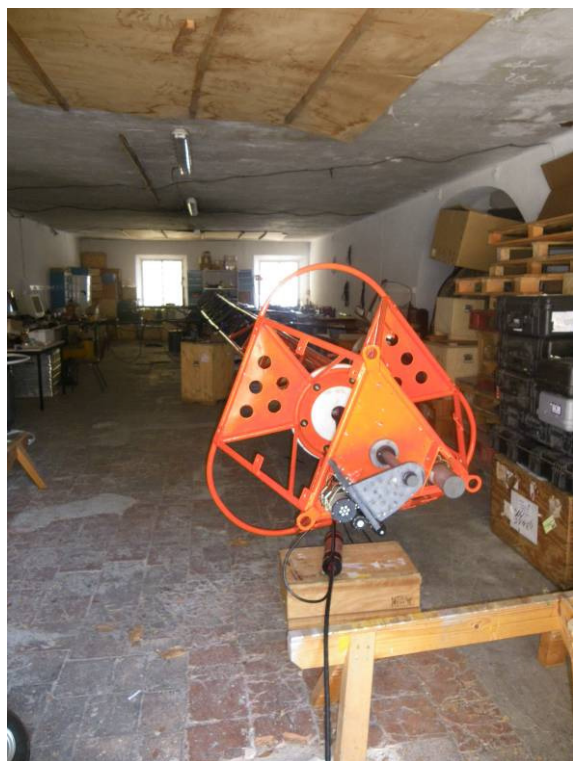
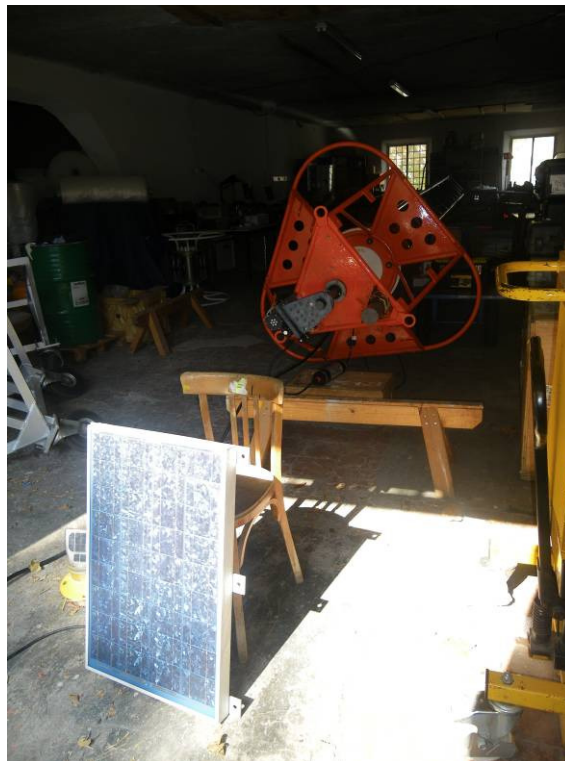
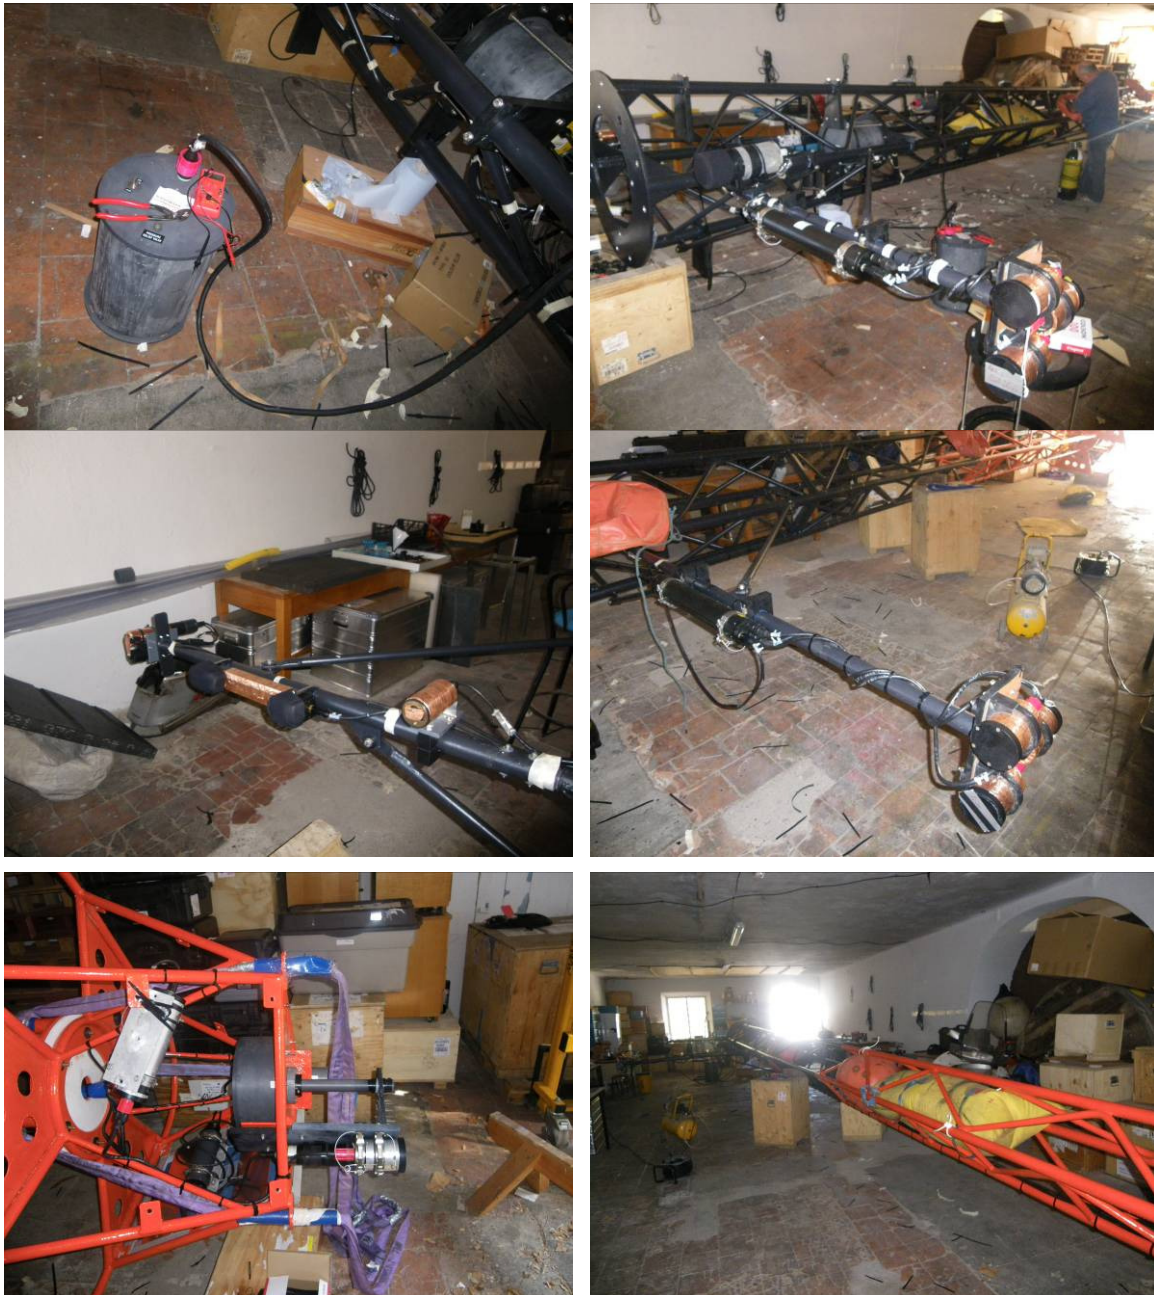
- high dark values for PAR sensor.
- Bad dark values on OCI#040 Eu 683 nm on OCP sn040
