Full rotation of the BOUSSOLE buoy and mooring September 15-18, 2019

V. VELLUCCI

BOUSSOLE Project

September 30, 2019

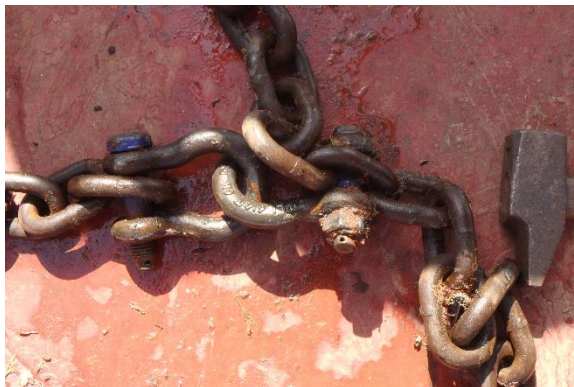
Pic. 12

- One of the shackles' screw along the chain linking the Kevlar cable to the buoy lower superstructure was missing (**Pic. 12**). This was due to complete corrosion of the security pin. The shackle was still capable to maintain the line as it was kept in its position by the strain generated by the buoy. It is recommended to 1) regularly verify the state of the shackles with divers (at least every 6 months) 2) verify the type of pins used to secure shackles (stainless steel is recommended).

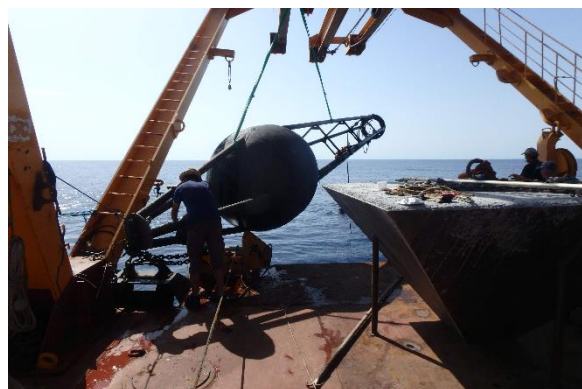
Pic. 13

- 14.45 End of the Kevlar cable recovery, the lower superstructure is partially put on board to remove the chain and the strain sensor (**Pic. 13**). The general condition of the structure is good, with almost no fouling. However the paint presents exfoliation and many blisters. The ARGOS emergency beacon, pCO₂+O₂ sensors and a seismograph (from GEOAZUR lab) are dismantled too and mounted on the new lower superstructure soon after. New batteries has been put inside the ARGOS beacon, however no message was received on land during the operations from this instrument.

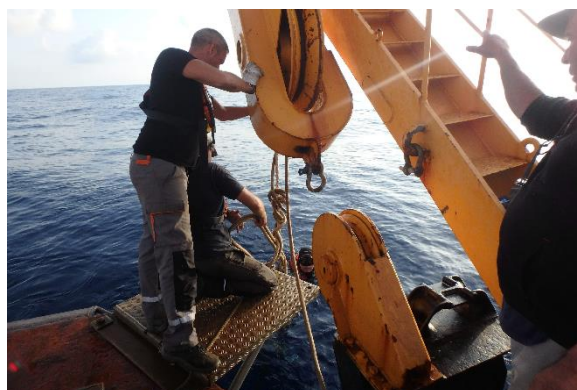
Pic. 30

- 07.45 The tension on the rope is increased to 1T. The rope is tangled with the winch cable (**Pic. 30**) and is replaced with a textile rope.
- 09.30 The rope tension is progressively increased to 2.7 T. This is verified through the tension display. Generally, during this operation, the ship should be as close as possible to the exact vertical of the mooring point where the dead weight ended up sinking. However, when upon the big float, the ship is at ~80 m from the release point and it is decided to start from this position to increase the tension, as the float trust acted on the mooring line overnight. This was particularly time effective as the desired tension on the cable was reached in few minutes.

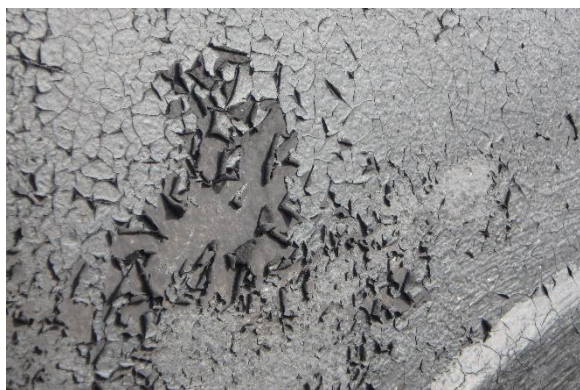
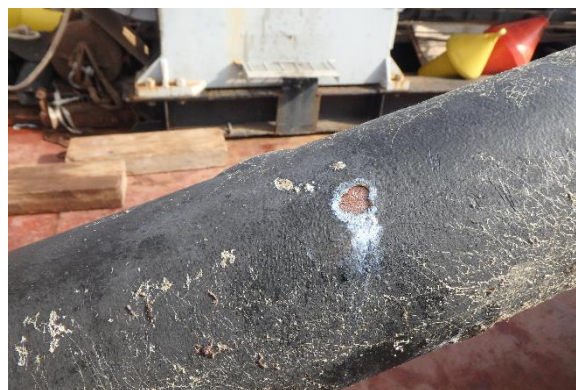
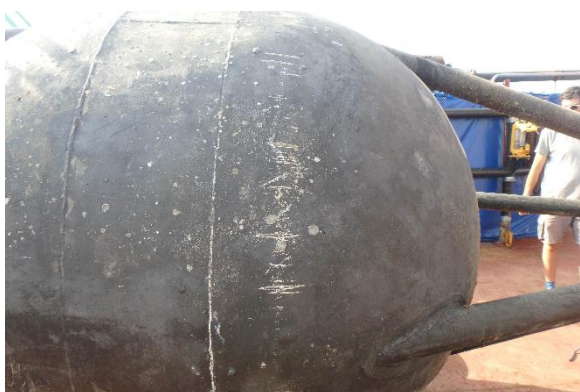
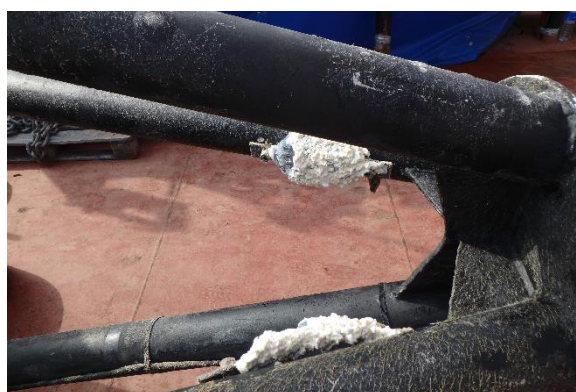
The last similar operation took place on 26th to 29th August of 2016. This means the mooring line and the lower superstructure have stayed at sea about 37 months. No particular issues on the Kevlar cable and terminations were noticed after they were retrieved except damage due to fishermen activities (see **Pic. 11**). The lower superstructure did not suffer biofouling however the condition of the paint was not good at visual inspection showing seawater infiltration in many points and rust formation (see **Pic. 43-46**).

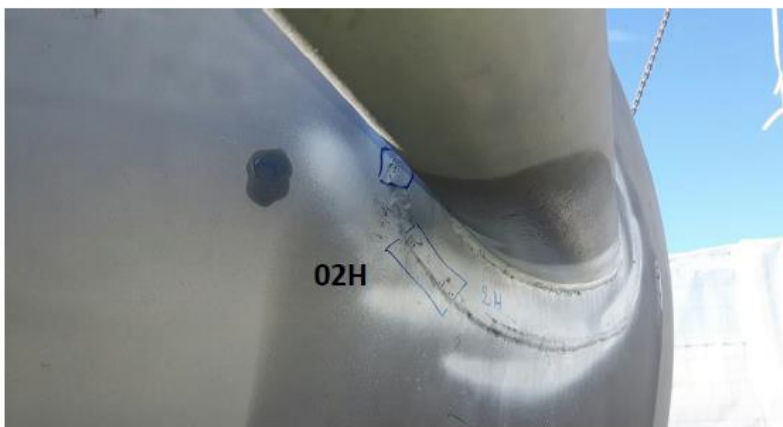
PIED 02

Présence de deux zones de porosité sur la soudure du renfort

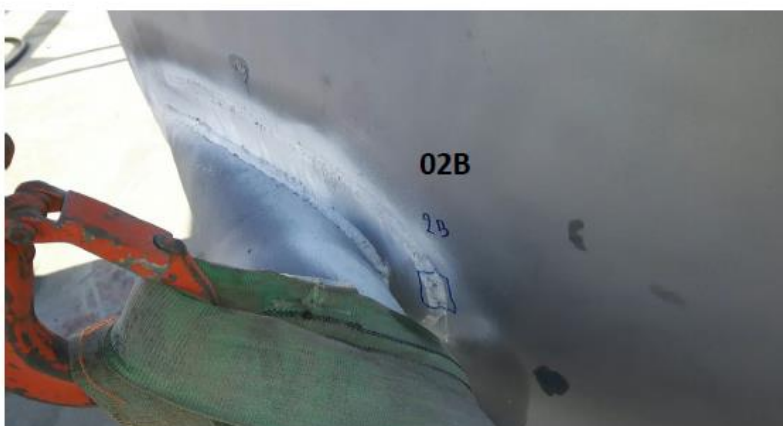
Présence d'une zone de porosité sur la soudure du renfort

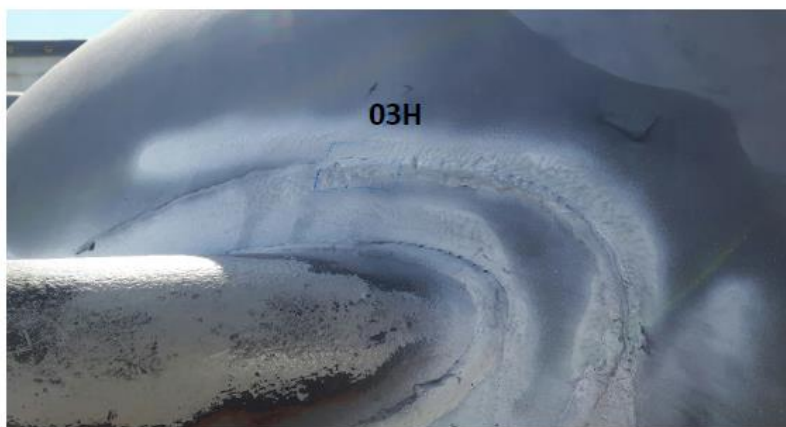
PIED 03

Présence d'une zone de porosité avec morsures sur la soudure du renfort

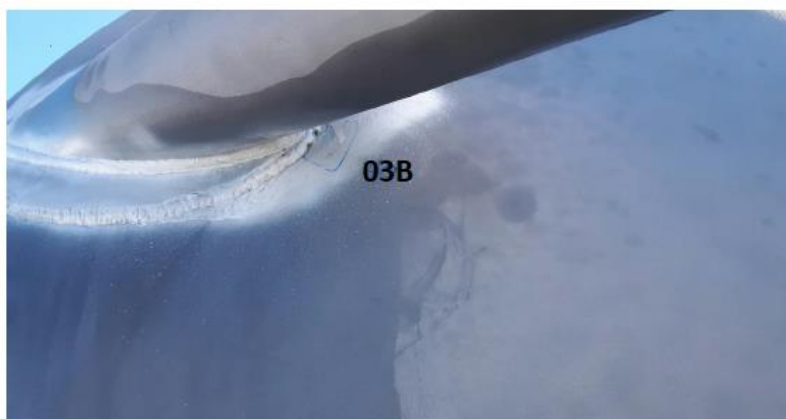
Présence d'une zone de piqûres sur la soudure du renfort

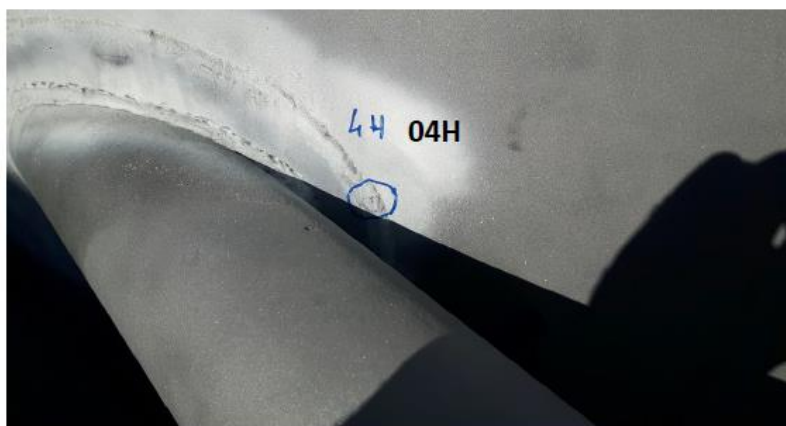
PIED 04

Présence d'une zone de porosité sur la soudure du renfort

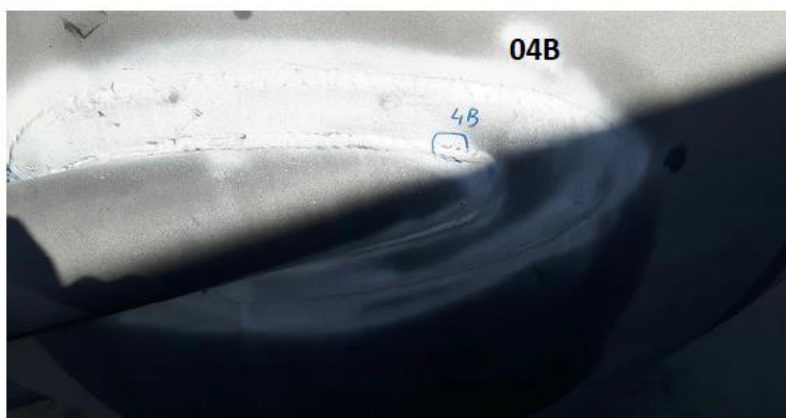
Présence d'une zone de piqûres sur la soudure du pied

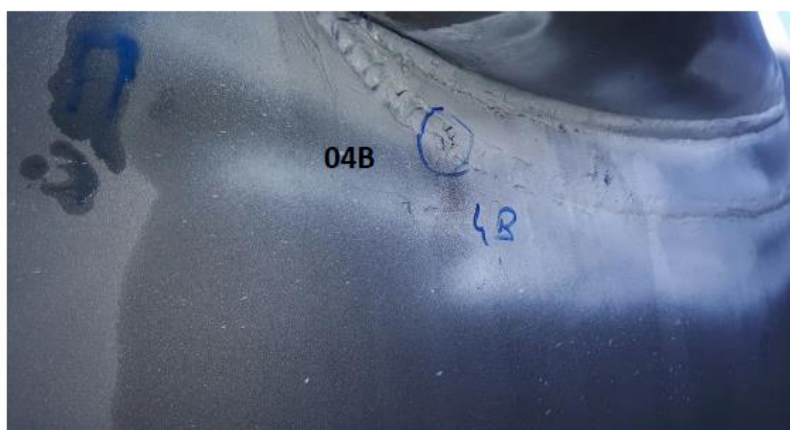
PIED 04 (Suite)

Présence d'une zone de porosité sur la soudure du renfort

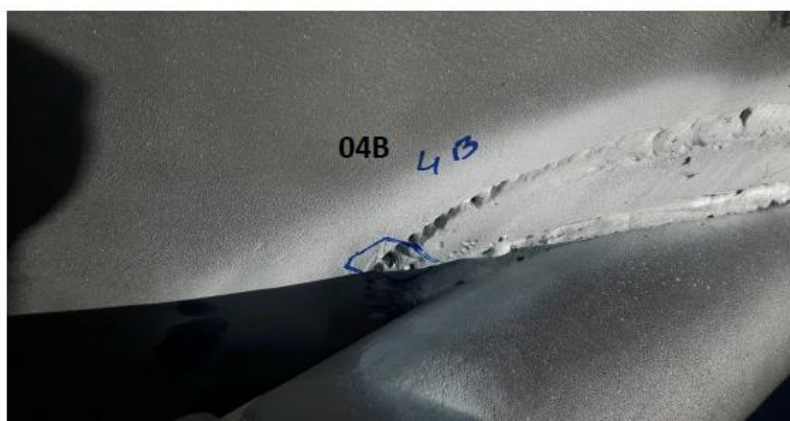
Présence d'une zone de piqûres sur la soudure du pied

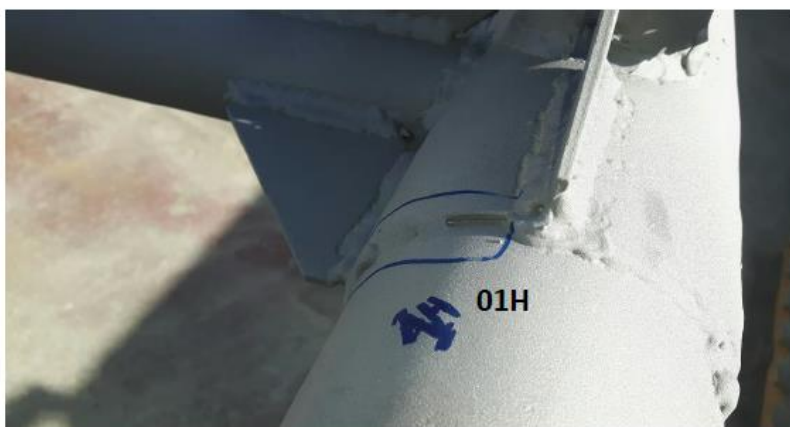
PIED 01H

Absence de bouclage du cordon de soudure du renfort

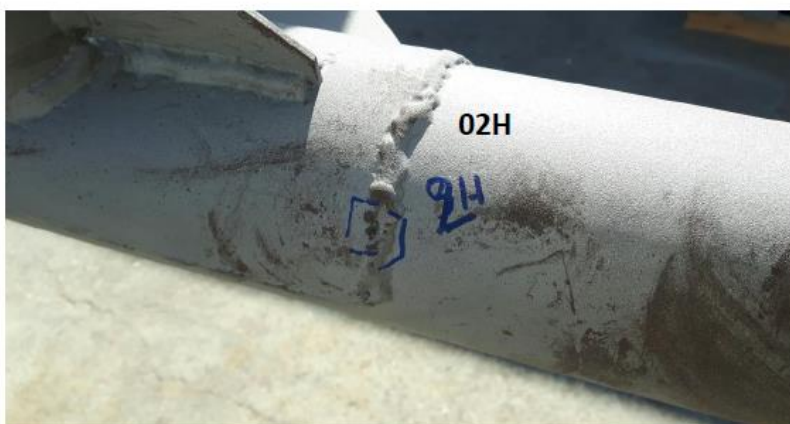
Présence d'une zone de piqûres sur la soudure du renfort

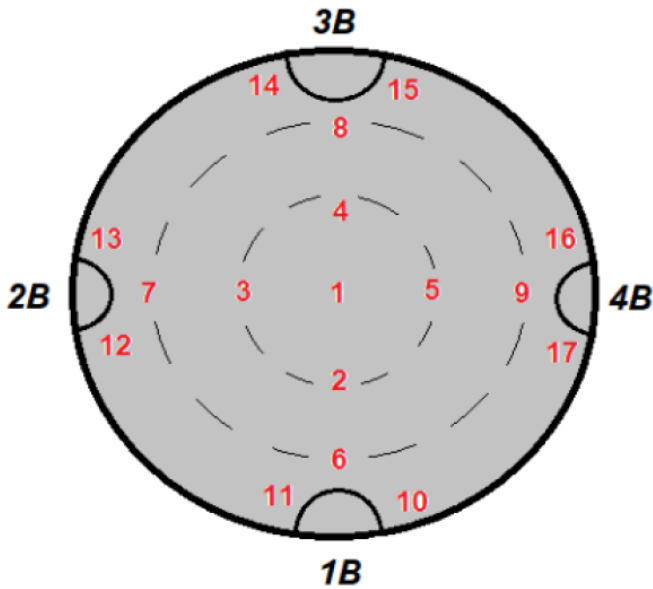
<table border="1" style="width: 100%; border-collapse: collapse; text-align: center;"> <tr> <td>Numéro du point</td> <td>1</td><td>2</td><td>3</td><td>4</td><td>5</td><td>6</td><td>7</td><td>8</td><td>9</td><td>10</td><td>11</td><td>12</td><td>13</td><td>14</td> </tr> <tr> <td>Valeur en mm</td> <td>6,0</td><td>5,9</td><td>5,8</td><td>5,9</td><td>5,9</td><td>4,7</td><td>5,2</td><td>5,3</td><td>5,2</td><td>4,0</td><td>4,7</td><td>4,0</td><td>4,2</td><td>4,3</td> </tr> </table>			Numéro du point	1	2	3	4	5	6	7	8	9	10	11	12	13	14	Valeur en mm	6,0	5,9	5,8	5,9	5,9	4,7	5,2	5,3	5,2	4,0	4,7	4,0	4,2	4,3

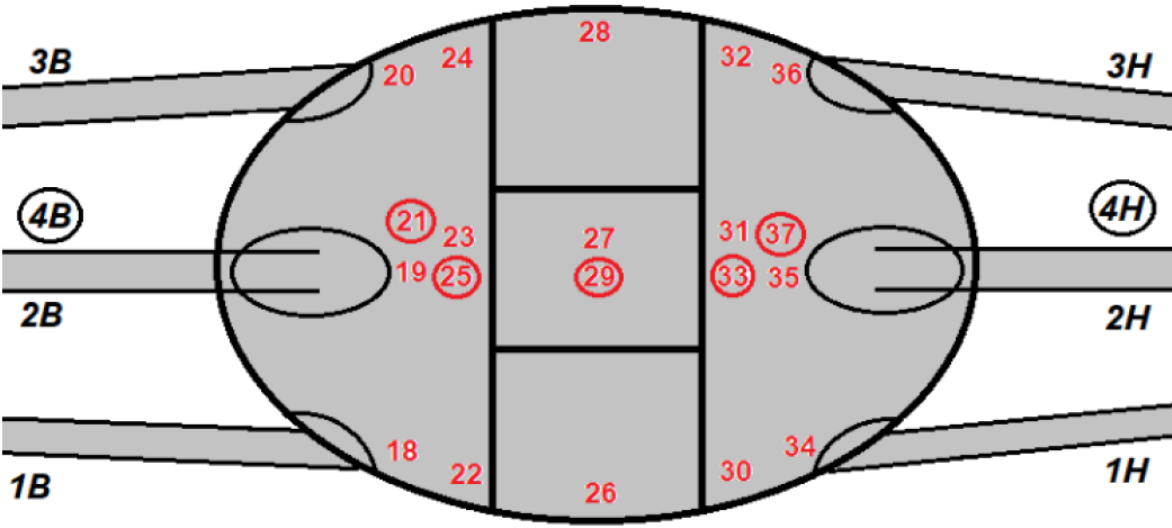
<p>Les valeurs mesurées sur les pieds 4B et 4H sont entourées pour une meilleur compréhension.</p>																																		
<table border="1"> <tr> <td>Numéro du point</td> <td>18</td><td>19</td><td>20</td><td>21</td><td>22</td><td>23</td><td>24</td><td>25</td><td>26</td><td>27</td><td>28</td><td>29</td><td>30</td><td>31</td> </tr> <tr> <td>Valeur en mm</td> <td>3,5</td><td>3,2</td><td>4,2</td><td>3,9</td><td>3,4</td><td>2,7</td><td>2,7</td><td>2,9</td><td>3,9</td><td>3,9</td><td>4,3</td><td>3,9</td><td>3,4</td><td>3,2</td> </tr> </table>					Numéro du point	18	19	20	21	22	23	24	25	26	27	28	29	30	31	Valeur en mm	3,5	3,2	4,2	3,9	3,4	2,7	2,7	2,9	3,9	3,9	4,3	3,9	3,4	3,2

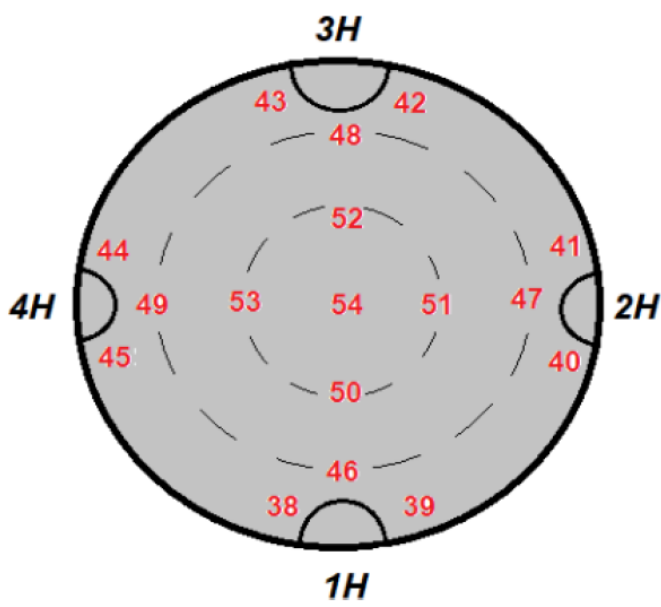
<table border="1" style="width: 100%; border-collapse: collapse; text-align: center;"> <tr> <td style="width: 15%;">Numéro du point</td> <td>38</td><td>39</td><td>40</td><td>41</td><td>42</td><td>43</td><td>44</td><td>45</td><td>46</td><td>47</td><td>48</td><td>49</td><td>50</td><td>51</td> </tr> <tr> <td>Valeur en mm</td> <td>4,2</td><td>4,4</td><td>4,6</td><td>4,3</td><td>4,8</td><td>4,8</td><td>4,6</td><td>4,7</td><td>4,9</td><td>4,6</td><td>4,6</td><td>4,8</td><td>6,1</td><td>5,6</td> </tr> </table>			Numéro du point	38	39	40	41	42	43	44	45	46	47	48	49	50	51	Valeur en mm	4,2	4,4	4,6	4,3	4,8	4,8	4,6	4,7	4,9	4,6	4,6	4,8	6,1	5,6
