The BOUSSOLE project technical reports; report #7-7, issue 1.

**BOUSSOLE buoy deployment & maintenance log.**  
**June 10, 2006 – February 12, 2007**

**BOUSSOLE project**

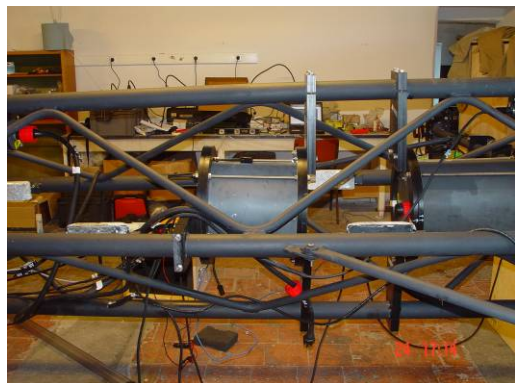
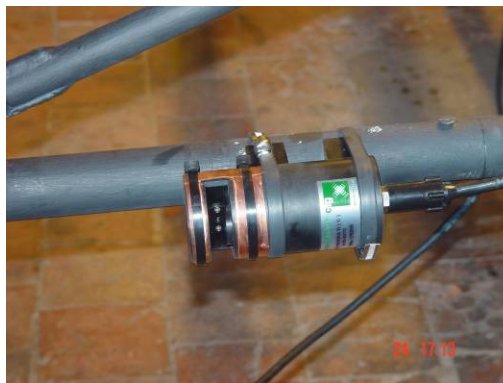
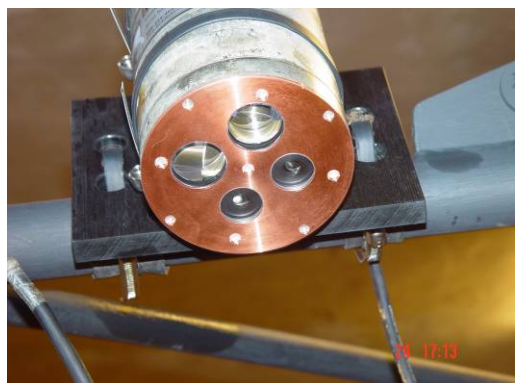
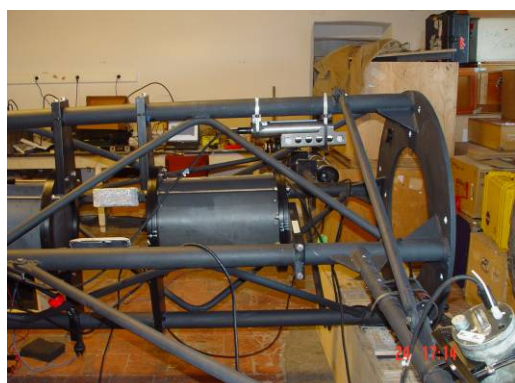
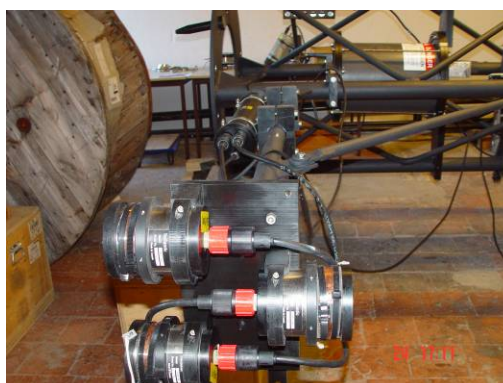
The Buoy was again prepared in the CCI local in Villefranche-Sur-Mer, and again the preparation was without any surprise thanks to the experience of the previous deployments. Copper sheets and pieces were again fixed wherever possible to avoid biofouling arising (see pictures).

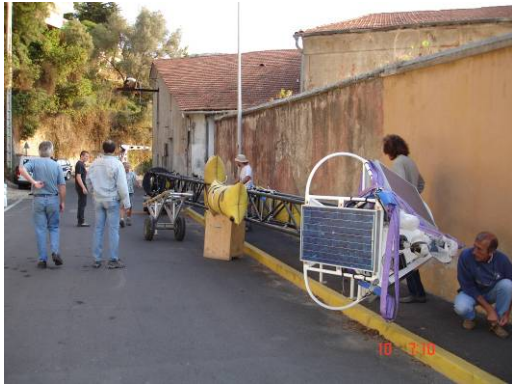
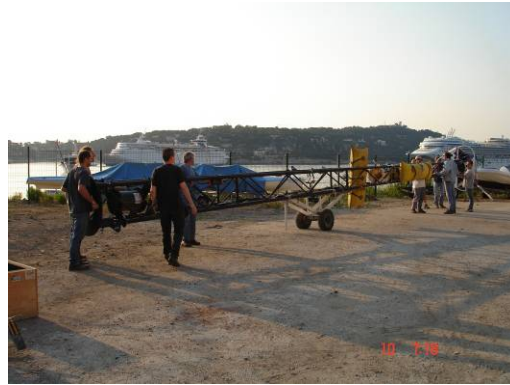
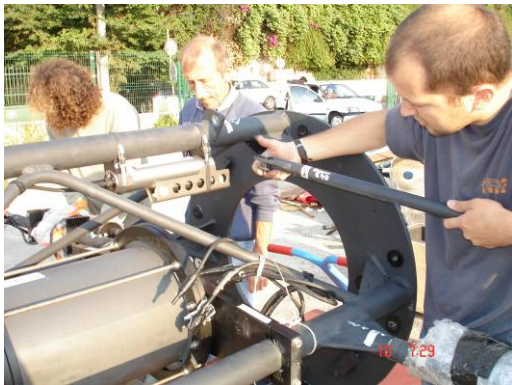
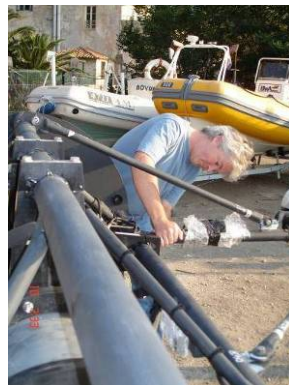
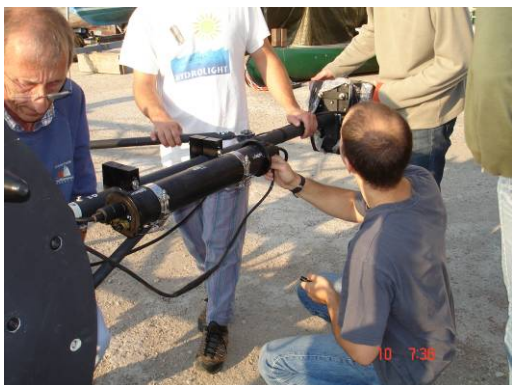
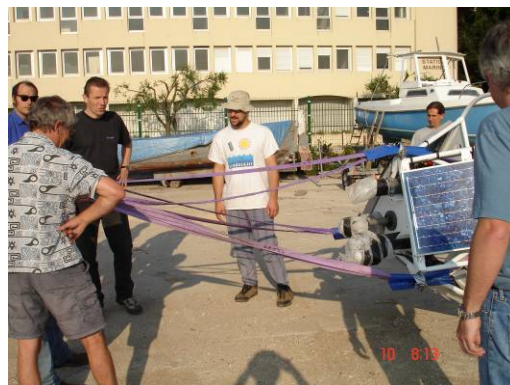
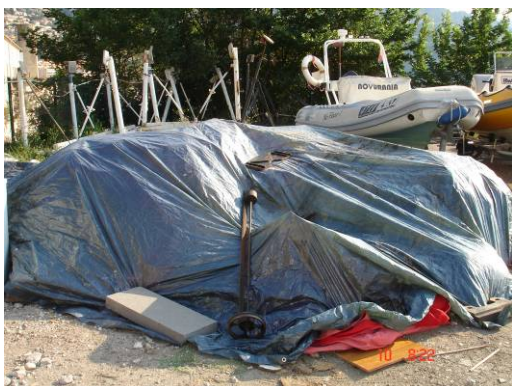
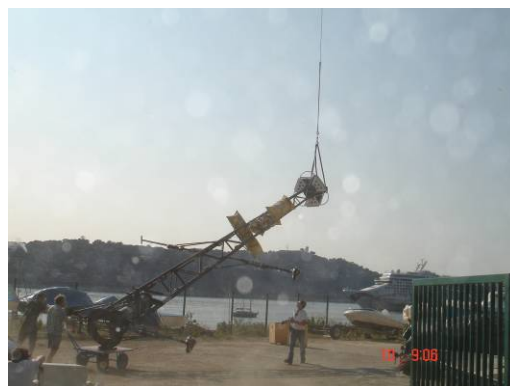
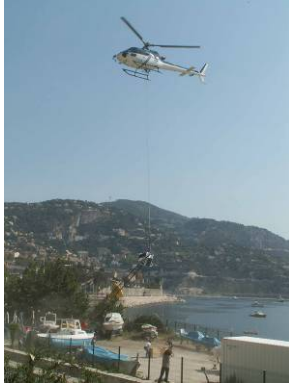
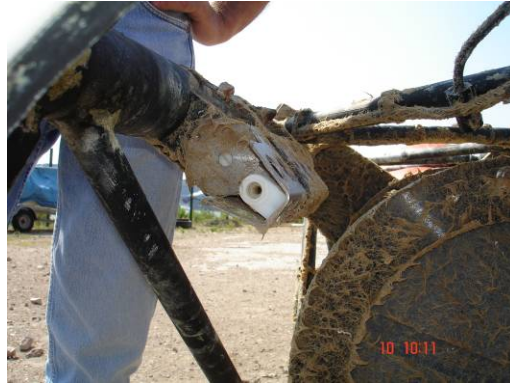
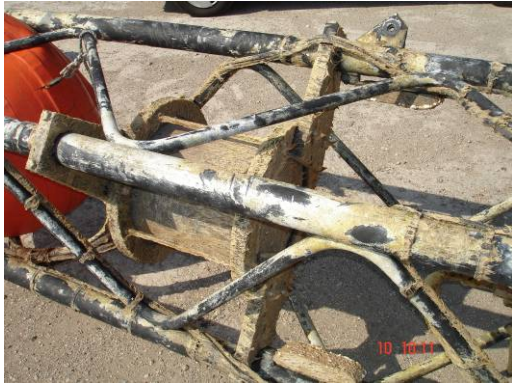
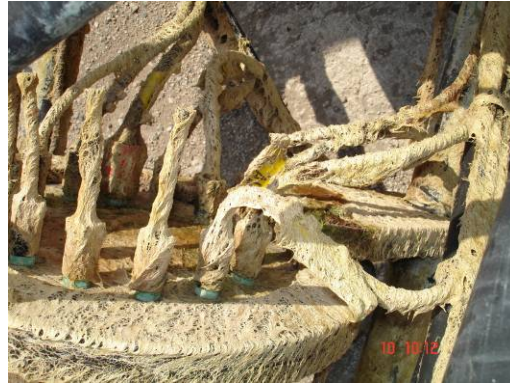
The new upper structure of the buoy was brought to the "Rochambeau" lot at 07am with the help of about 10 people from the LOV. One hour later, the 4 arms were assembled and connected to the buoy, and the Rochambeau lot was a little bit cleaned (at least some tarpaulins were put on some light and volatile detritus clusters) and the helicopter pilot was called to fetch the buoy a few minutes before 09am.

One hour later, the helicopter brought back the ancient buoy that was disassembled by SAMAR divers on the preceding day. All the exchange operations were performed without any problem.

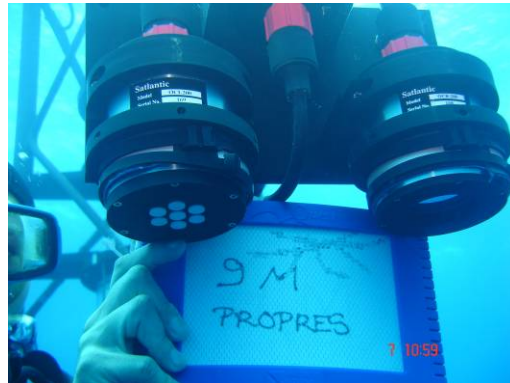
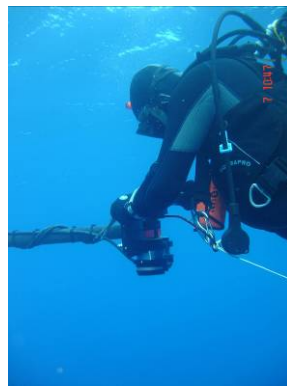
This day is part of the BOUSSOLE 55 mission. Divers checked the buoy structure and sensors state under the sea surface, and cleaned the optical surface of the instruments.

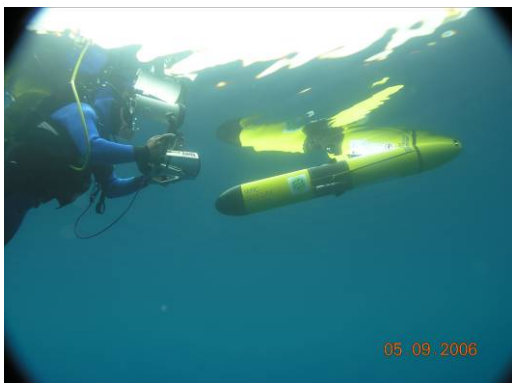
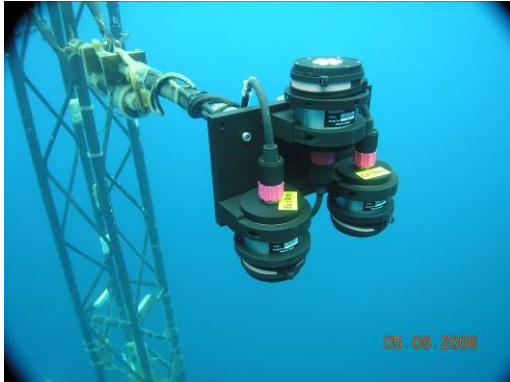
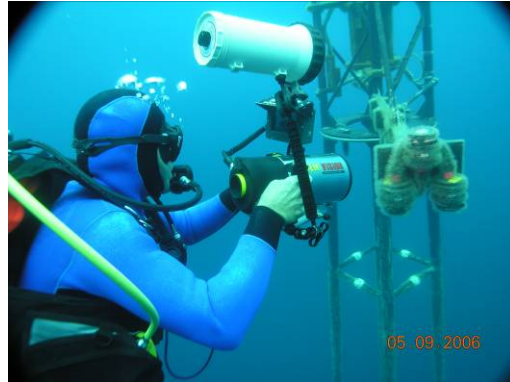
This day is part of the BOUSSOLE 56 mission. Divers checked the buoy structure and sensors state under the sea surface, and cleaned the optical surface of the instruments.

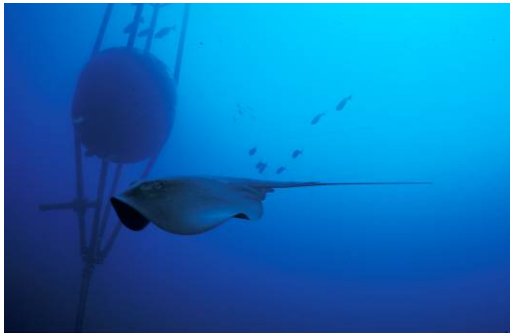
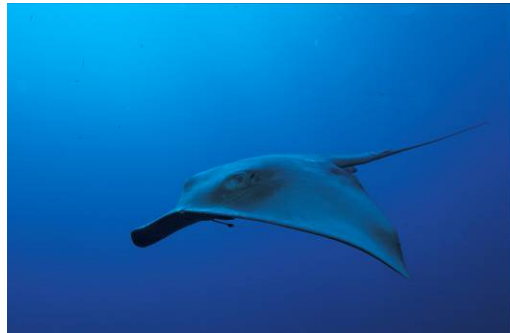
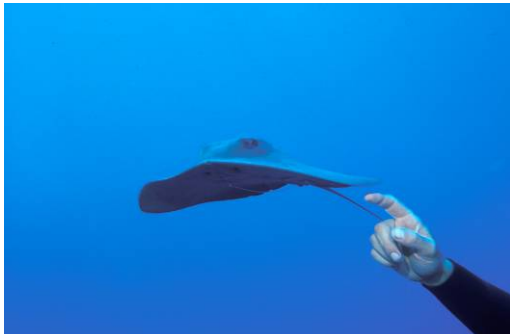
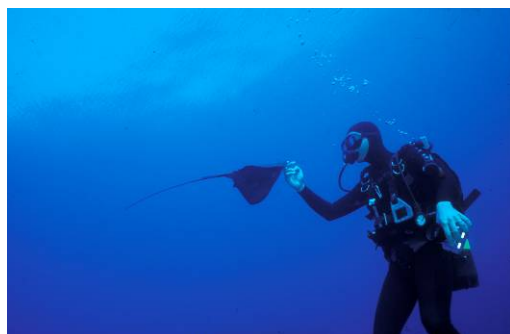
This day is part of the BOUSSOLE 57 mission. Divers checked the buoy structure and sensors state under the sea surface, and cleaned the optical surface of the instruments.

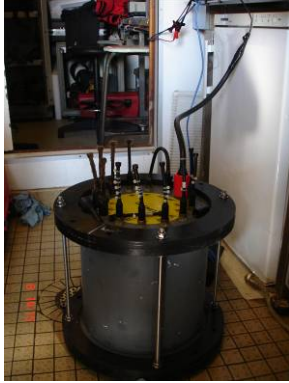
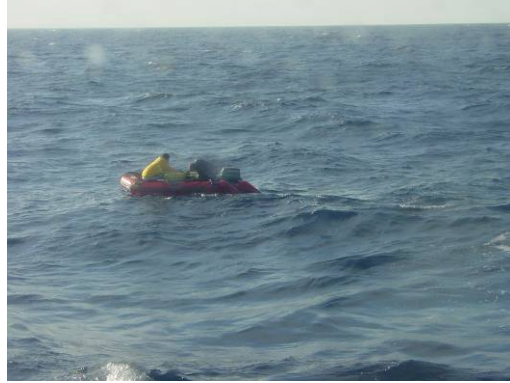
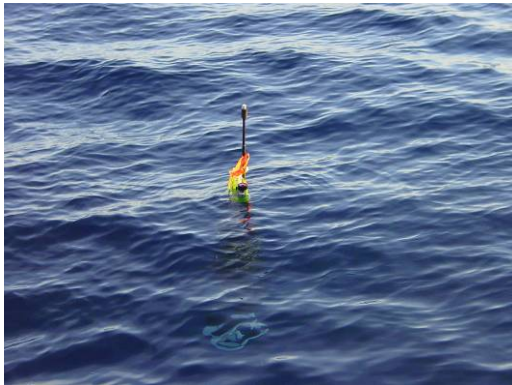
This day is part of the BOUSSOLE 58 mission. Divers checked the buoy structure and sensors state under the sea surface, and cleaned the optical surface of the instruments.

As the buoy had stopped recording data and communication since Saturday 21<sup>st</sup> October, 2006, the DACNet was disassembled from the buoy and brought back on the ship deck. After a simple connection to a laptop when powered by a power supply (in the ship lab), the DACNet was found to work properly, and was immediately reassembled on the buoy.

The problem was sought on the side of the buoy power supply, i.e. the battery + CLC + Junction Box + solar panels set. After inspection of the Junction Box with a voltmeter, it appeared that

power arrived from solar panels but wasn't transmitted to the CLC, as no signal was recorded at the output of the Junction Box.

Unfortunately, the weather conditions roughened suddenly, and the Junction Box couldn't either be brought back to the LOV or in the ship lab for inspection.

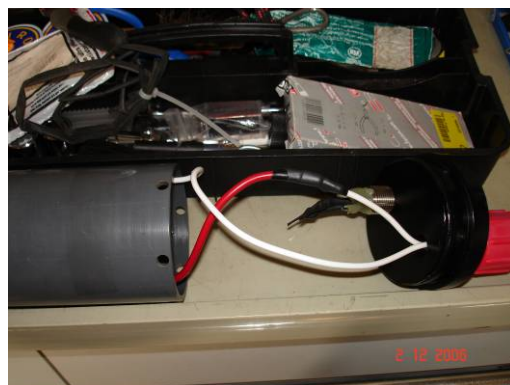
This day is part of the BOUSSOLE 59 mission. Divers checked the buoy structure and sensors state under the sea surface, and cleaned the optical surface of the instruments. The Junction Box could this time be brought back in the ship lab, and it was found that an electric pod inside the Box was broken (unfortunately the ground pod, so that no solar panels could power the battery via the CLC). The pod was shortcut, and so was the magnetic rotary switch of the Junction Box, as it was found to be a little bit jammed (especially the same switch was broken on the buoy battery few weeks before). Few hours after the Junction Box had been reassembled on the buoy, the data recording began again.

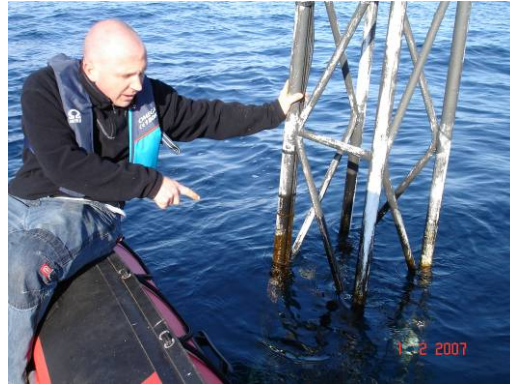
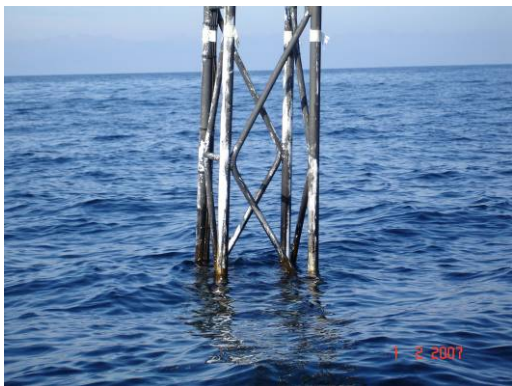
This day is part of the BOUSSOLE 60 mission. Divers checked the buoy structure and sensors state under the sea surface, and cleaned the optical surface of the instruments.

The antifouling paint of the buoy began to be used up.
