The BOUSSOLE project technical reports; report #7-7, issue 1.

**BOUSSOLE buoy deployment & maintenance log.**  
**June 10, 2006 – February 12, 2007**

**BOUSSOLE project**

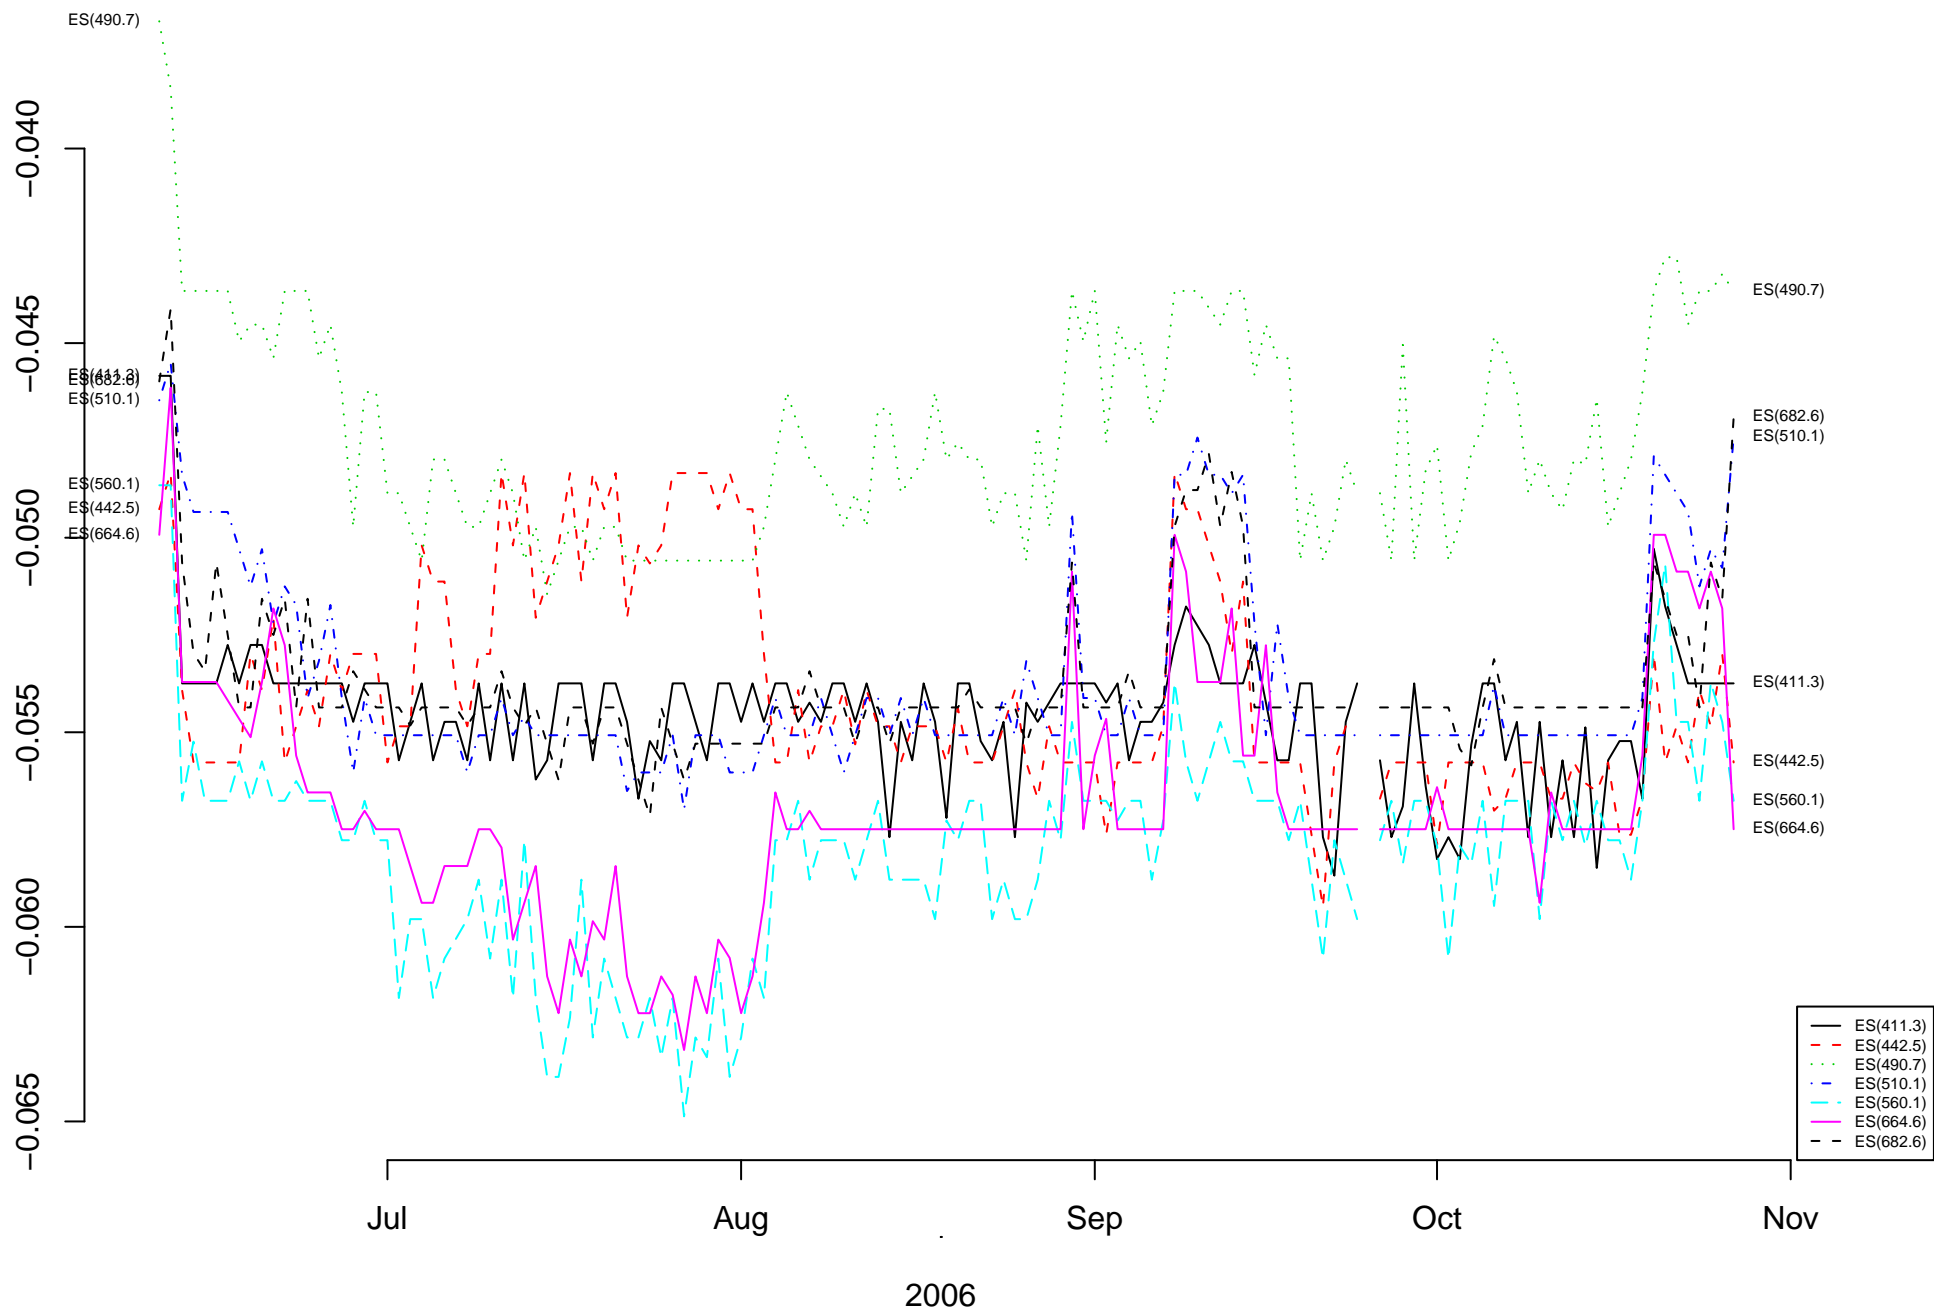
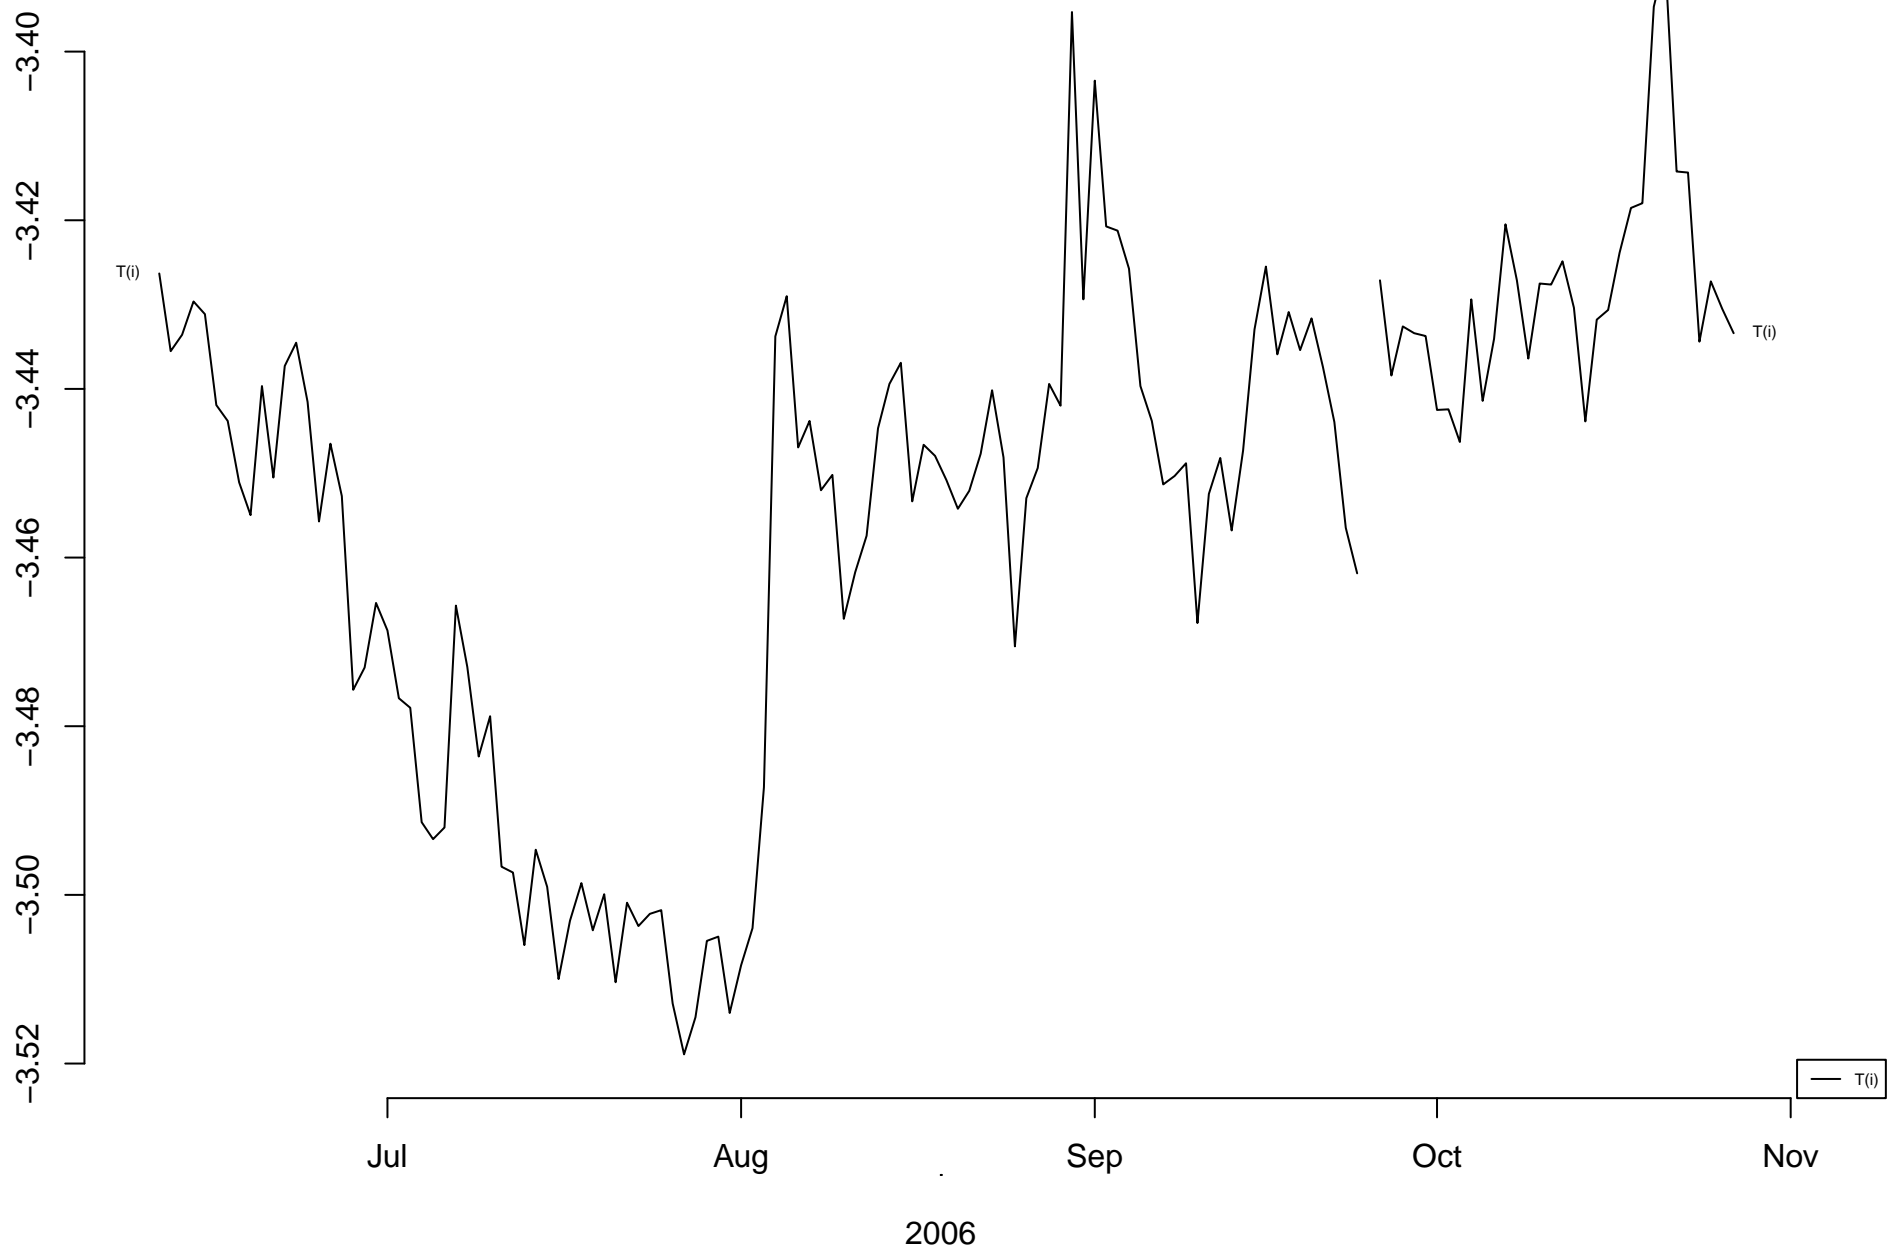
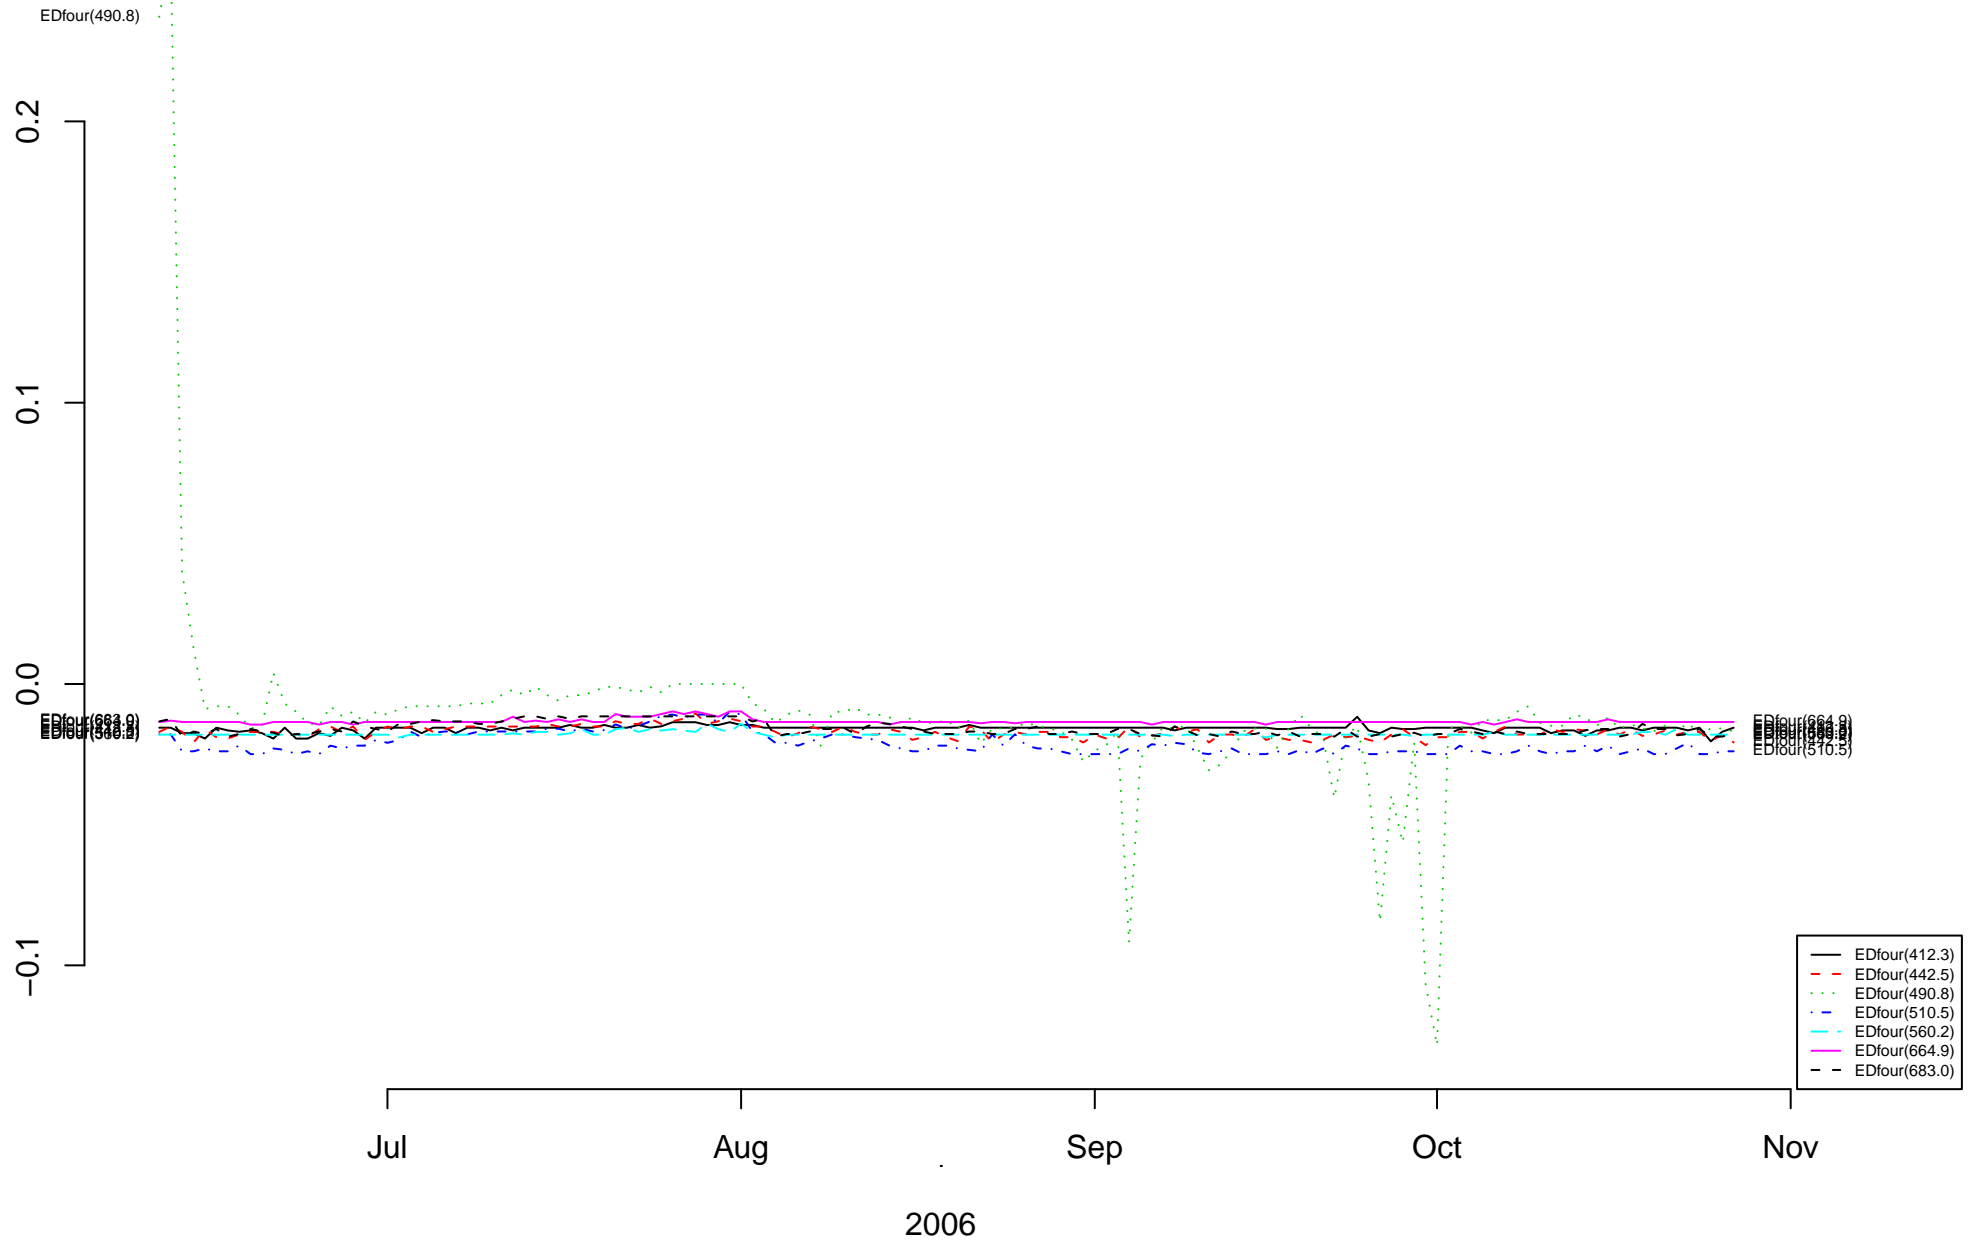
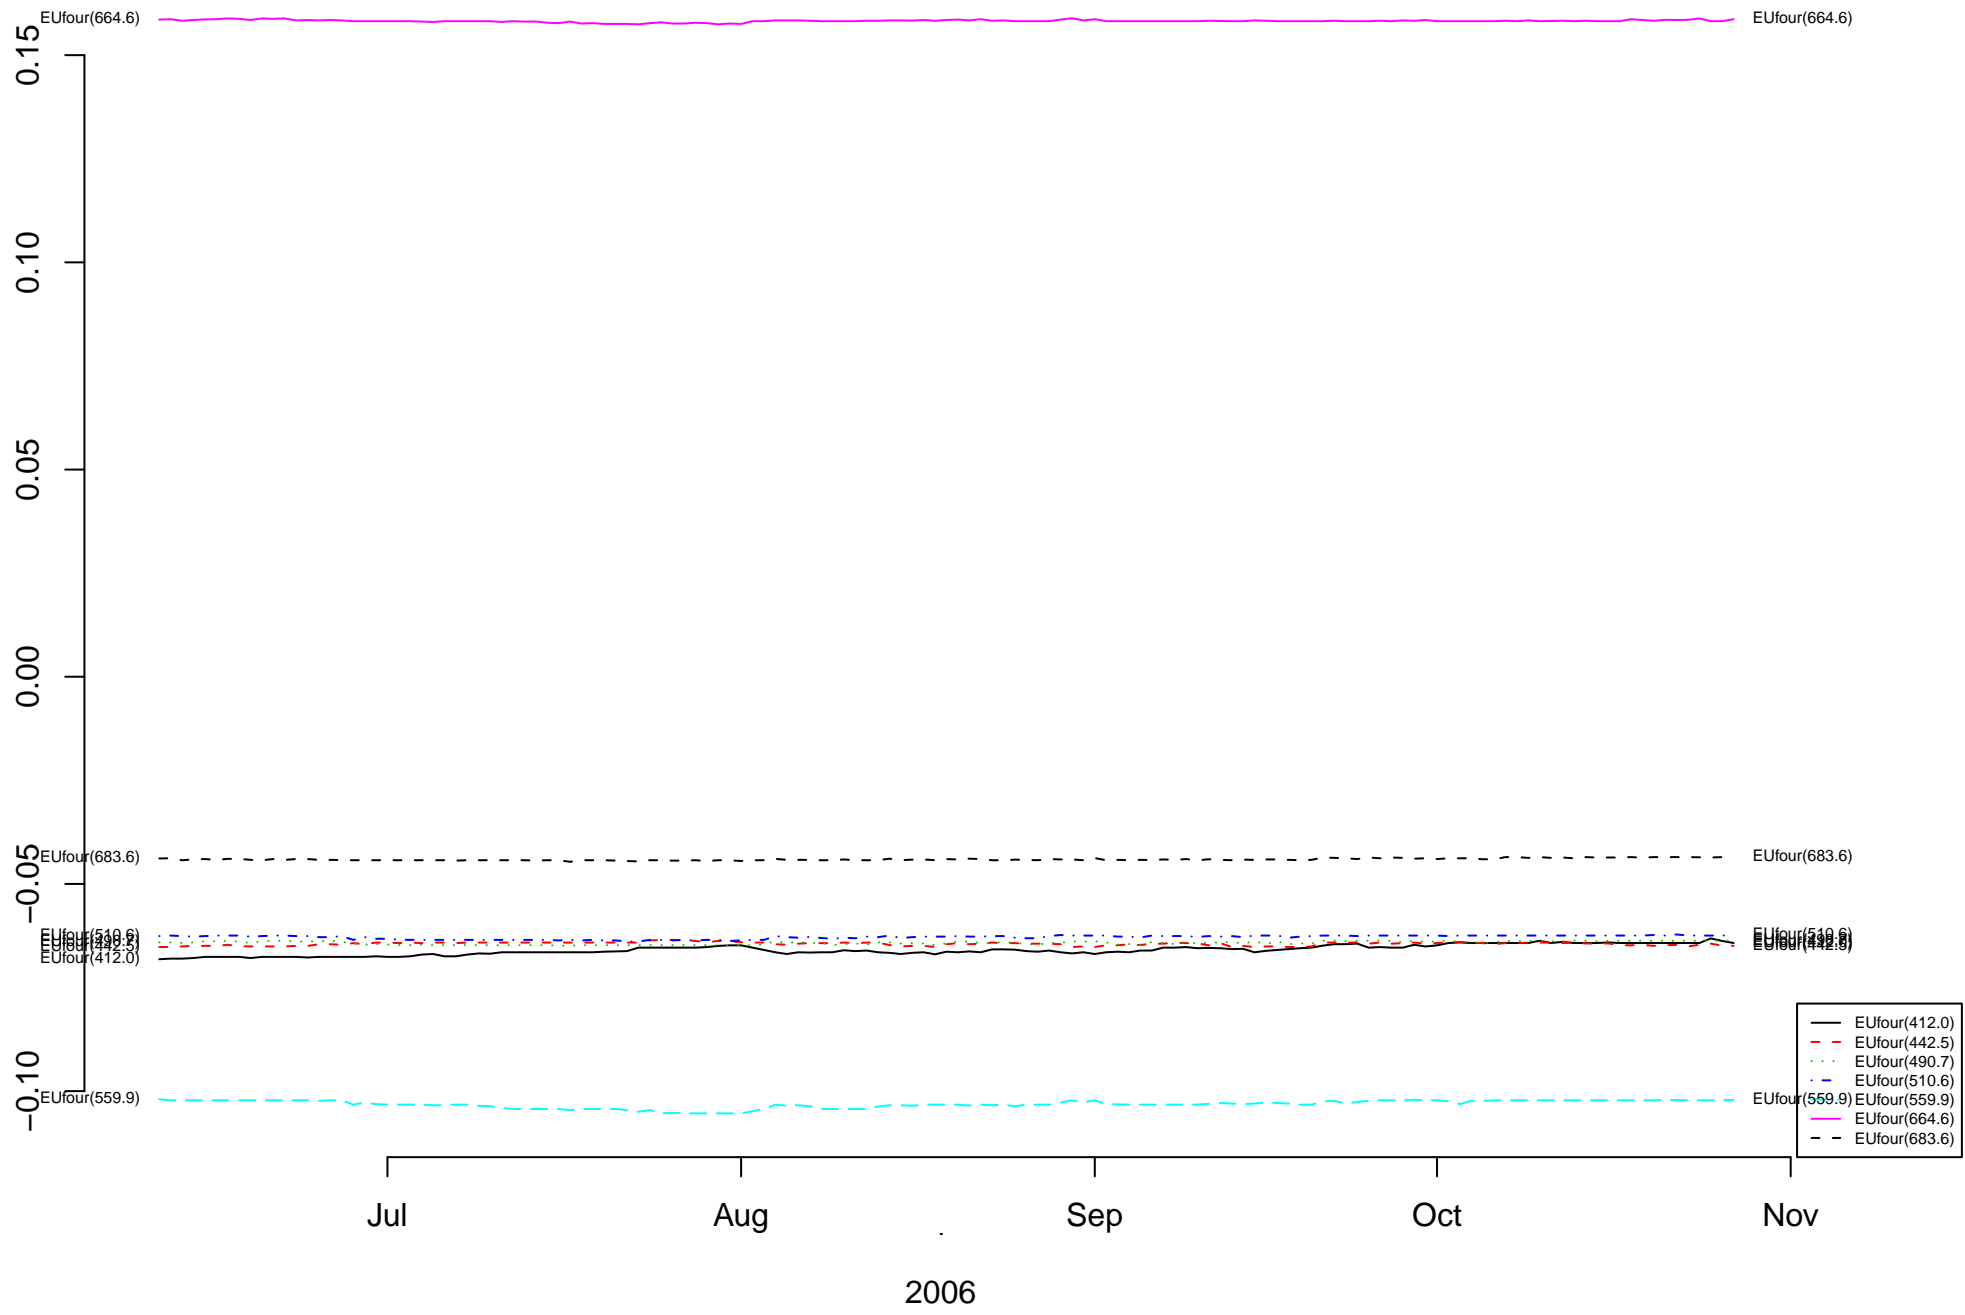
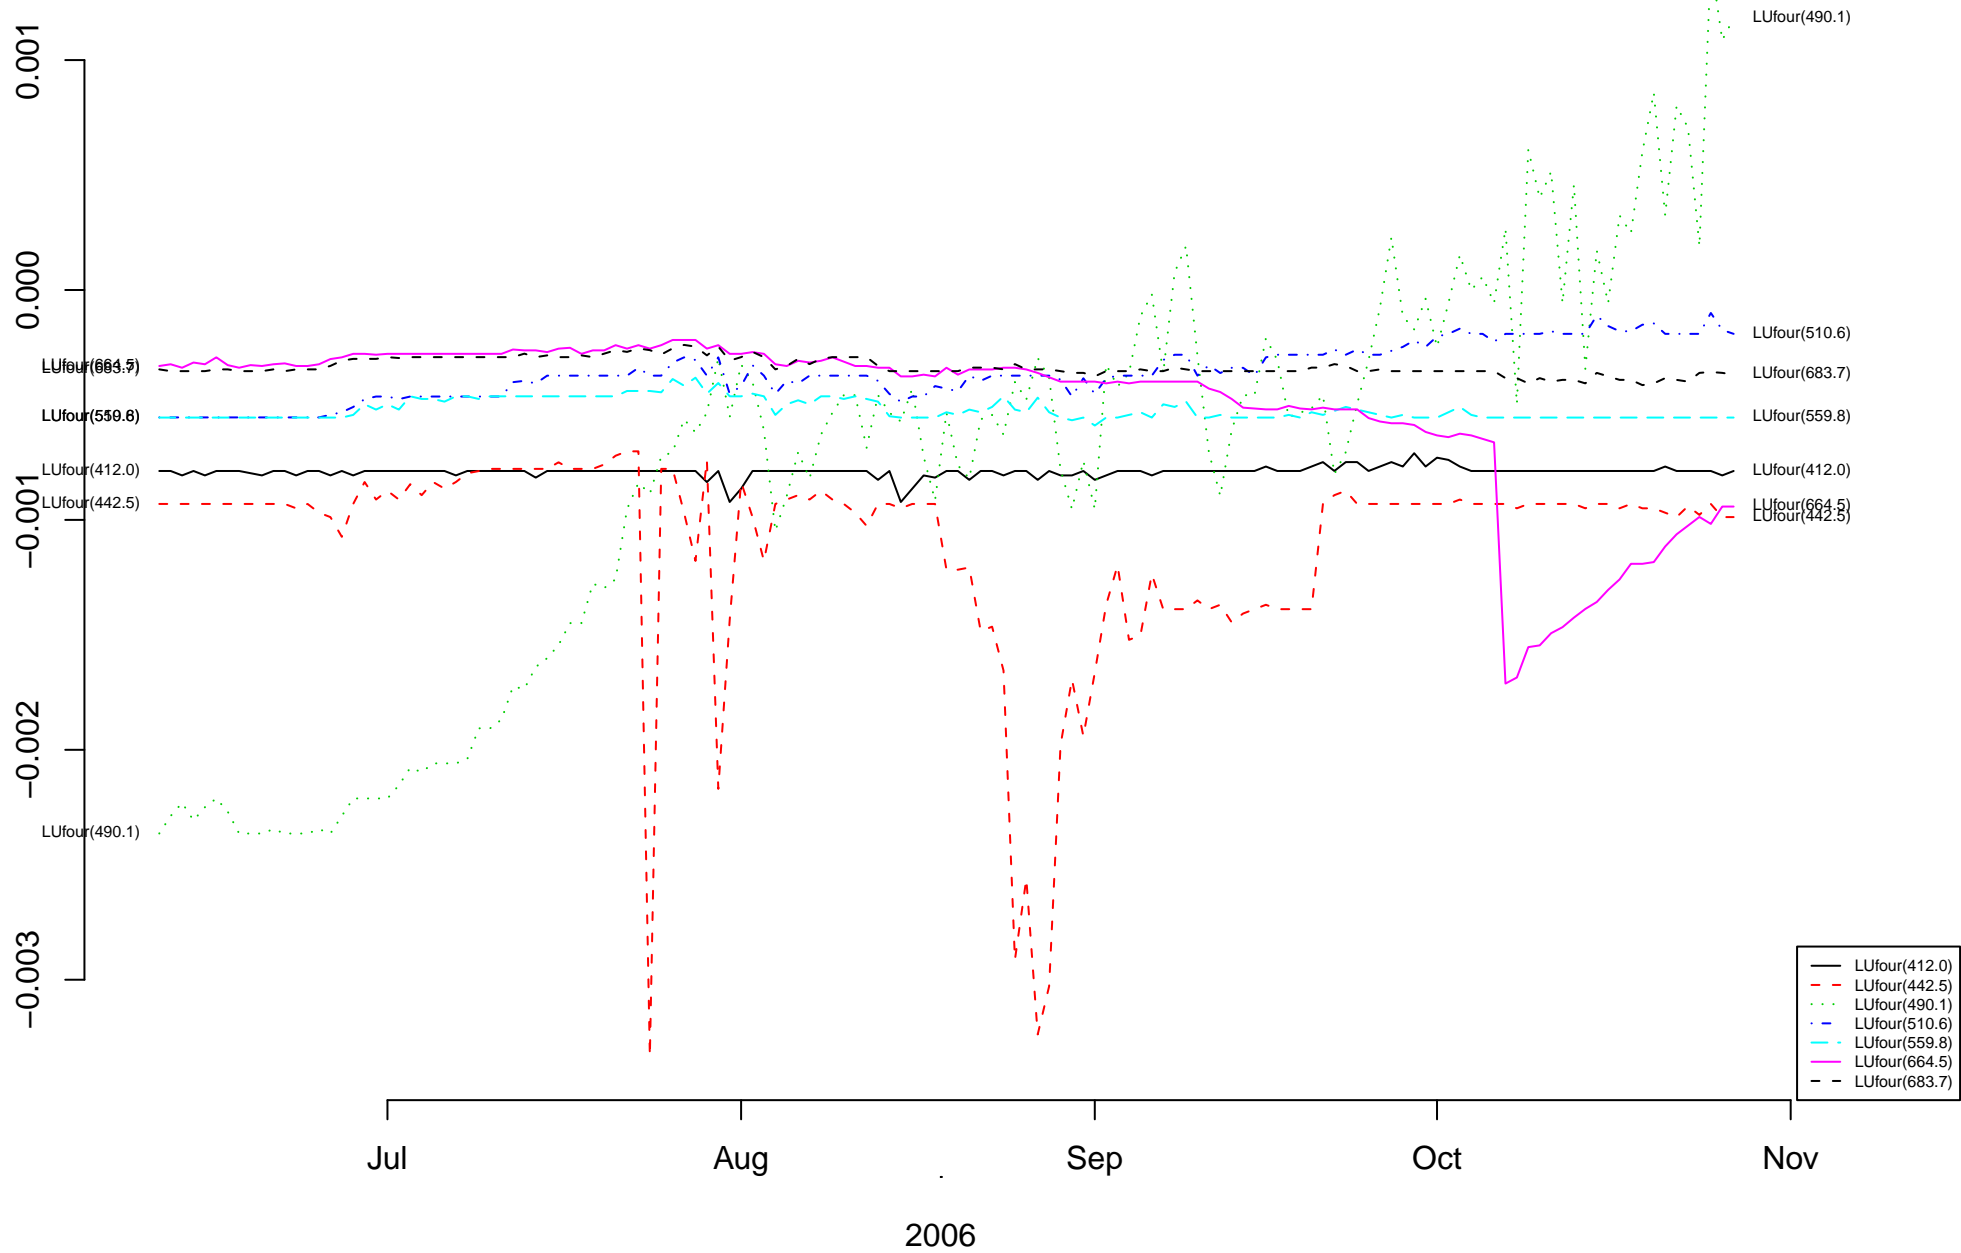
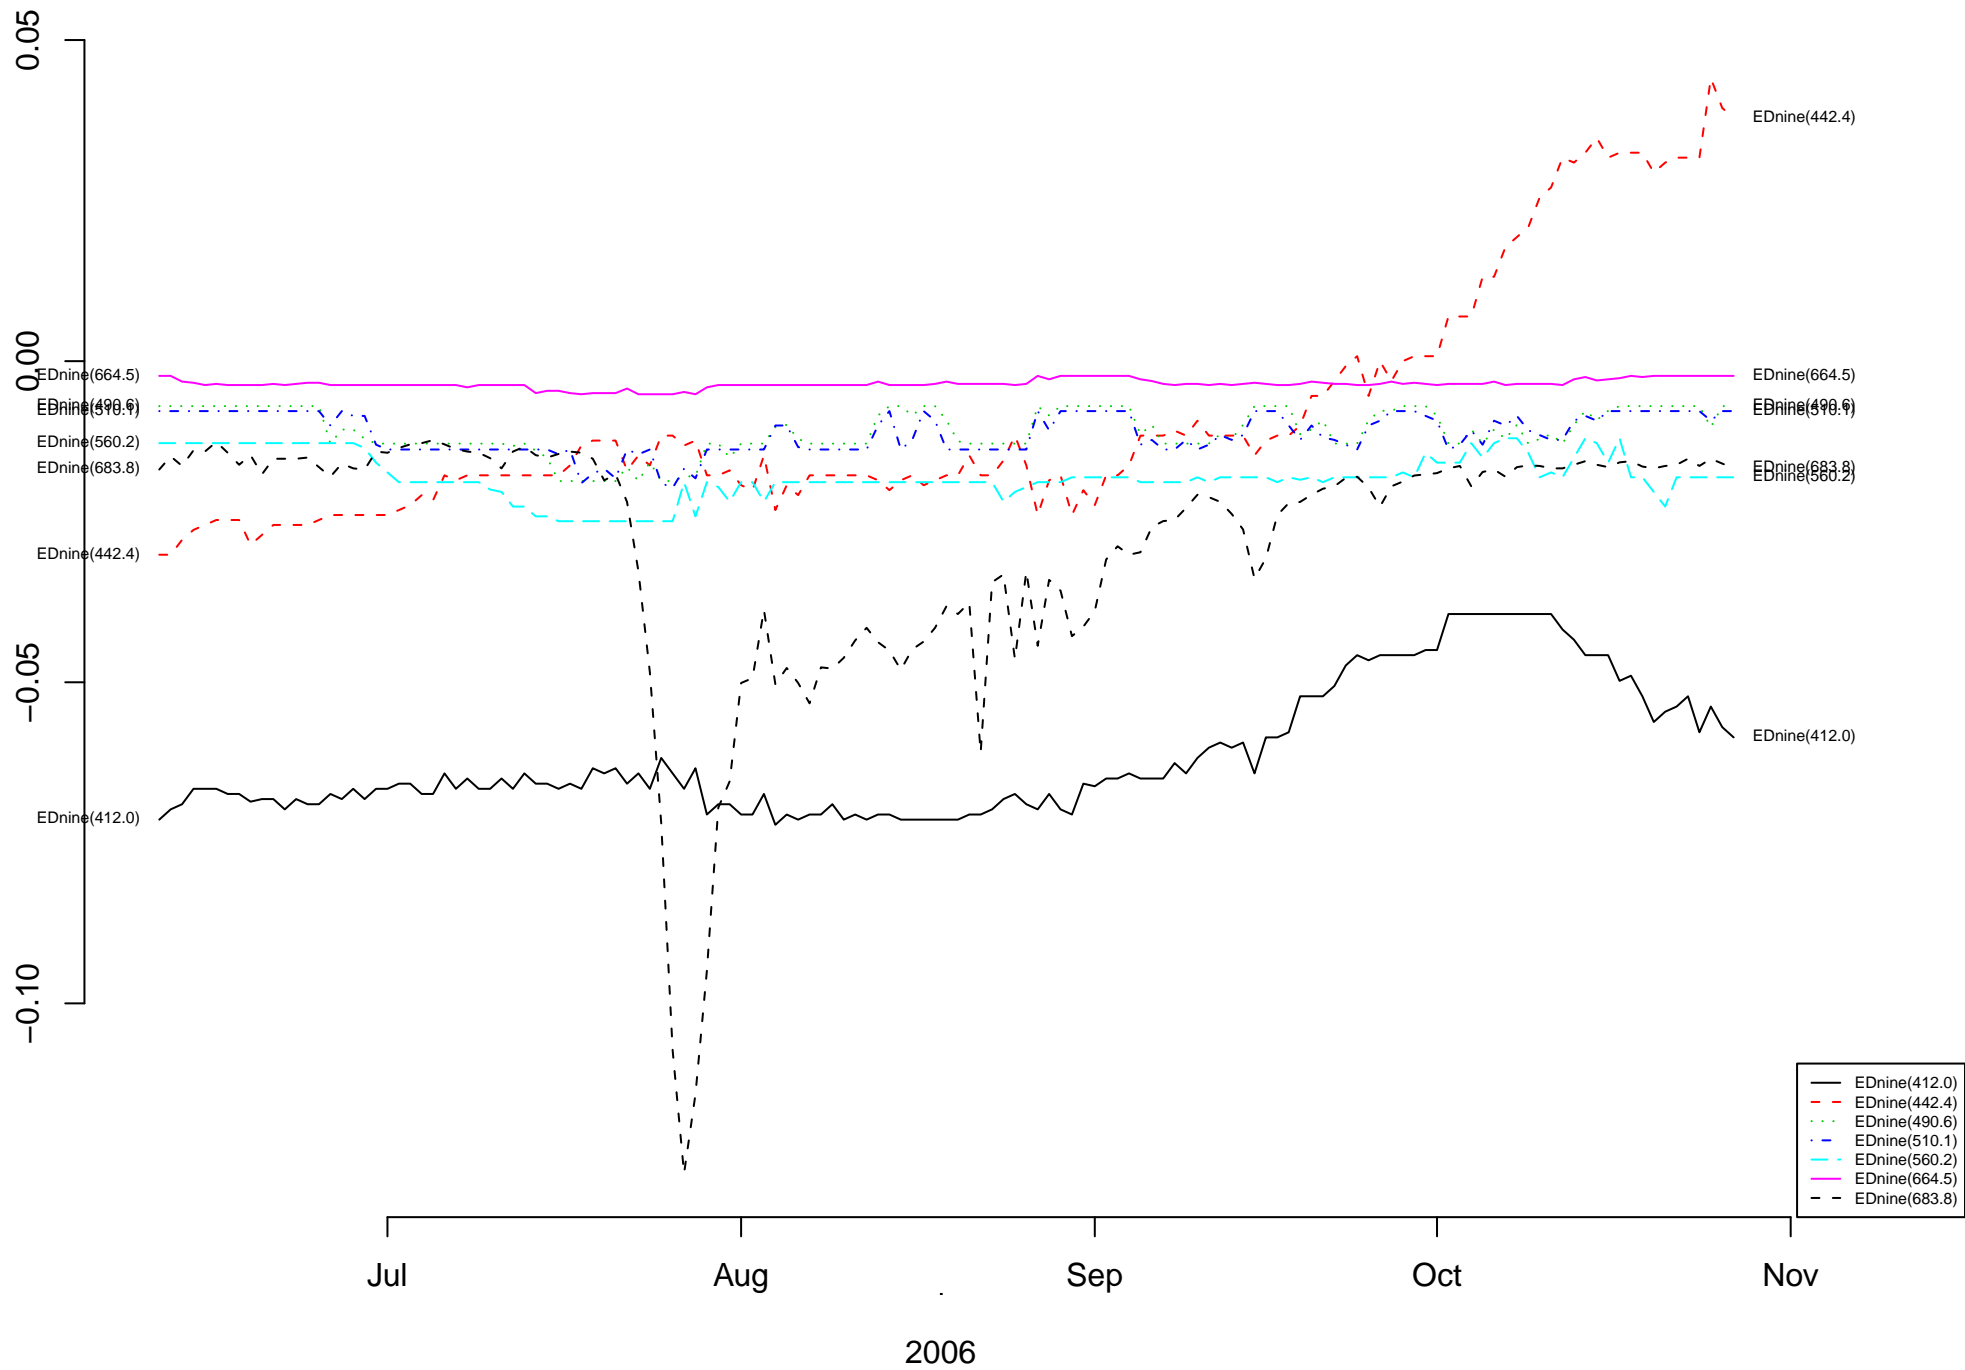
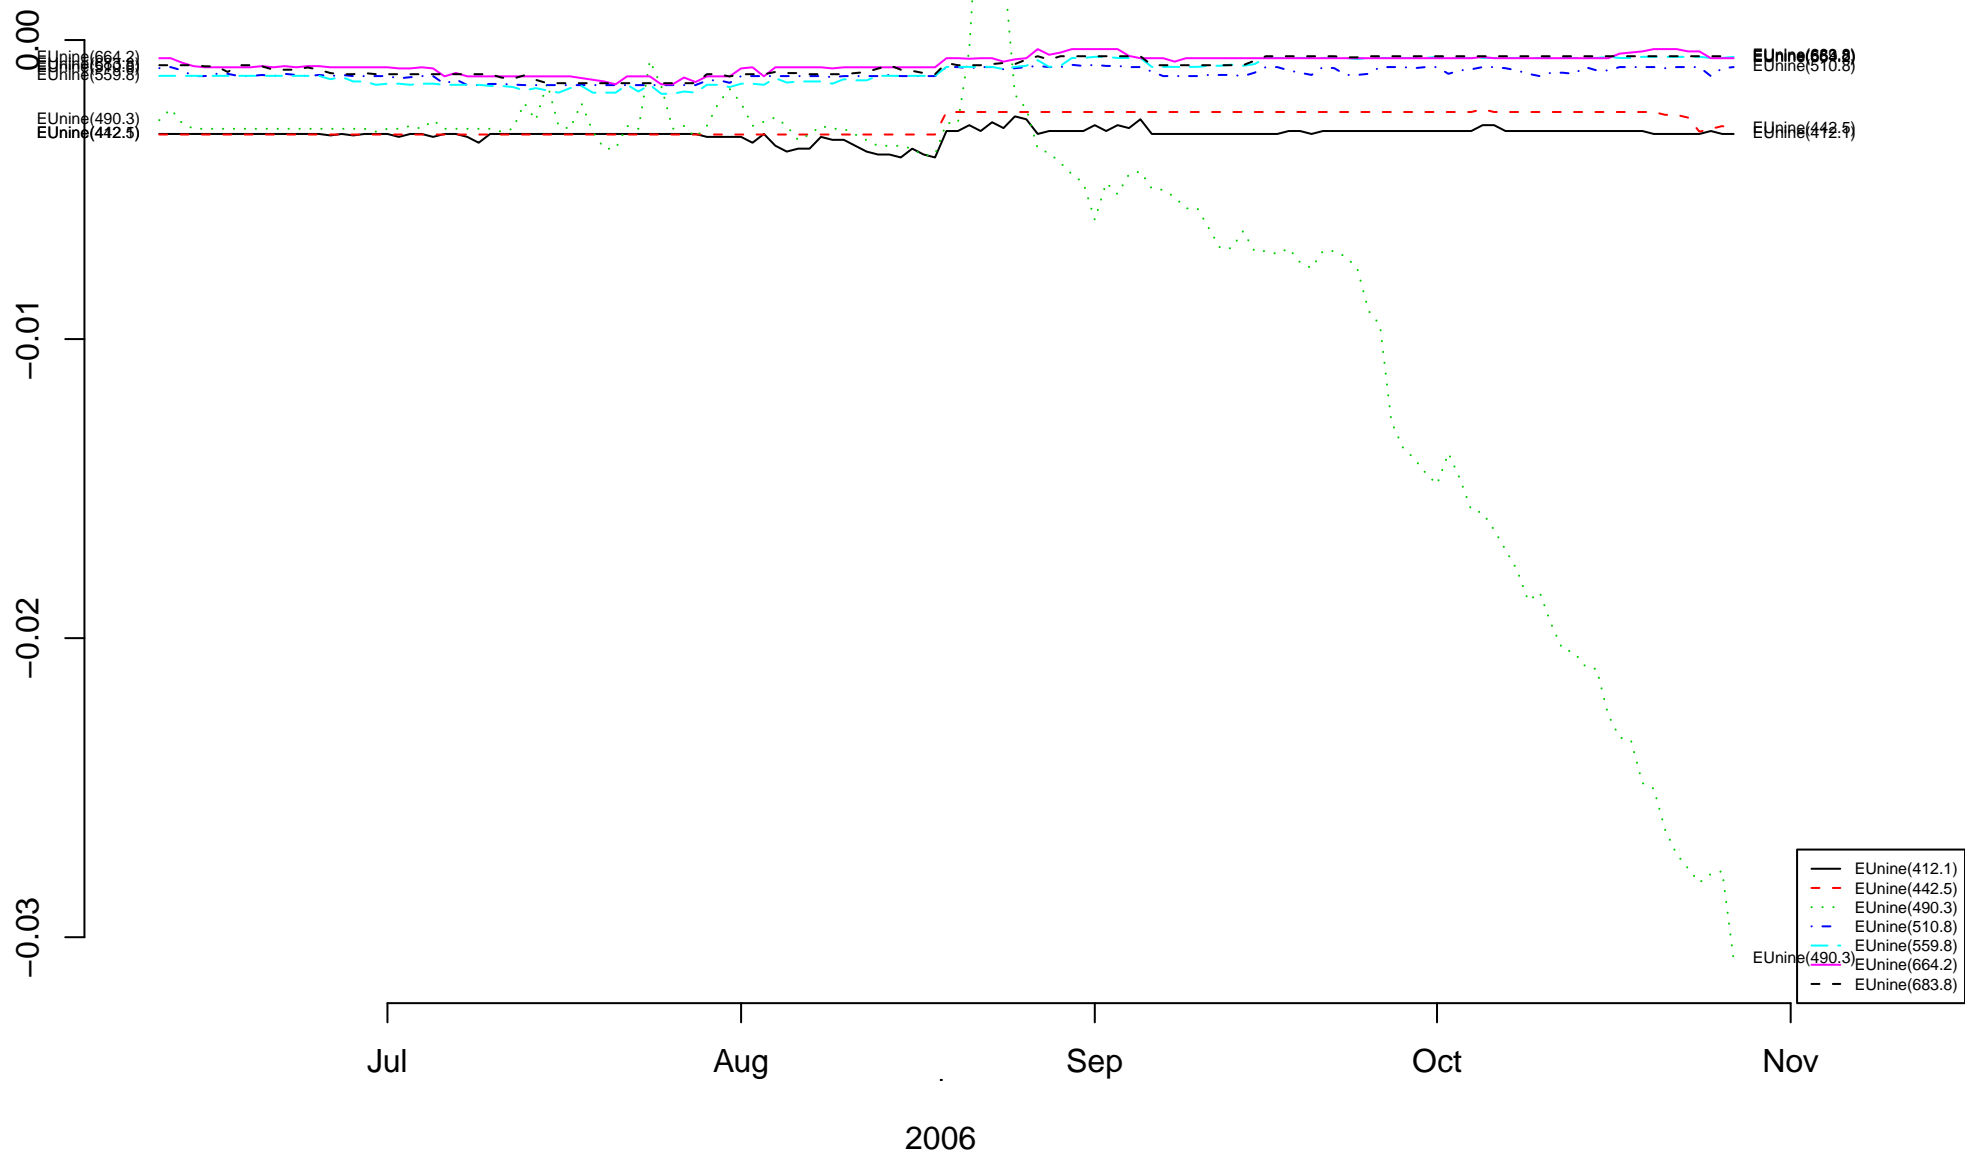
## **8. DAILY DATA COLLECTION SHEETS**

The following pages are meant to summarize the data collected each day by the buoy.
