The	ROUSSOL	Forniect	technical	renorts.	report #7-9	issue 1
1116	BUUJJUL	יספוטוע ב.	recrimica	1 1 6 0 0 1 1 3,	1 6 DOI 1 77 / - 2	, 133UE 1.

# BOUSSOLE project ESA/ESRIN contract N° 17286/03/I-OL Deliverable from WP#300/100

The BOUSSOLE buoy deployment and maintenance log is a record of all events that occur from the deployment to the recovery of one of the two upper sections of the buoy.

The present report concerns "buoy deployment 6", from September 22 of 2007 to January 20 of 2008.

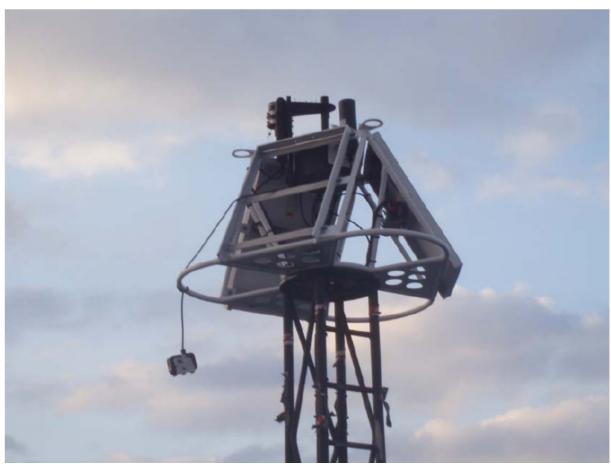
This day divers from the private company Mare Nostrum went at the BOUSSOLE site for cleaning the buoy system. The photovoltaic plate of one of the solar panel was missing.

This day a boat (Kelly) from a private company in Antibes (ABYS) was rent to go at the BOUSSOLE site. The mission was organized to perform the operation previewed, but not made, during the last cruise (#70): exchanging of both 4m and 9m OCPs and replacement of

one solar panel. Five persons were on board: Grigor Obolenssky, Vincenzo Vellucci, Lèo Gimenez and other two divers of his company. The boat left the port of Antibes at 09:30 and reached the BOUSSOLE site at 11:30. The buoy was not visible so we tried to locate it by making spirals around the point without success. A derive test indicated strong surface current.

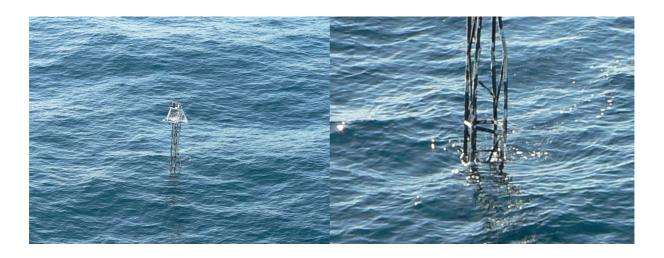
This day a helicopter survey at the BOUSSOLE site was performed to verify the general condition of the buoy which was last seen on December 18<sup>th</sup>. The helicopter, rent from a private company in Carros, left at 12:00 and arrived on site about 25 minutes later. The buoy appeared in bad conditions: all photovoltaic plates of the solar panels were missing and the main aluminium tubes of the upper structure were curved (see pictures). A detailed inspection of the photos taken, revealed that one of the tubes was cut, so we decided to remove the upper structure of the buoy as soon as possible.

This day the upper part of the buoy was removed from the BOUSSOLE site and brought at LOV. Léo Gimenez and other two divers of his company went on site with a private boat to dismantle the buoy and to fix it to the helicopter. At 12:30 the helicopter arrived in Villefranche, where 6 people from the LOV were attending to recover the buoy at the Rochambeau field and to bring it into the CCI local. The operation was completed without any problem.

The arms of the buoy were dismounted on site and stocked on the  $\it Thethy~II$ , on that day working at DYFAMED site for the MOOSE project and gently made available for support to divers.

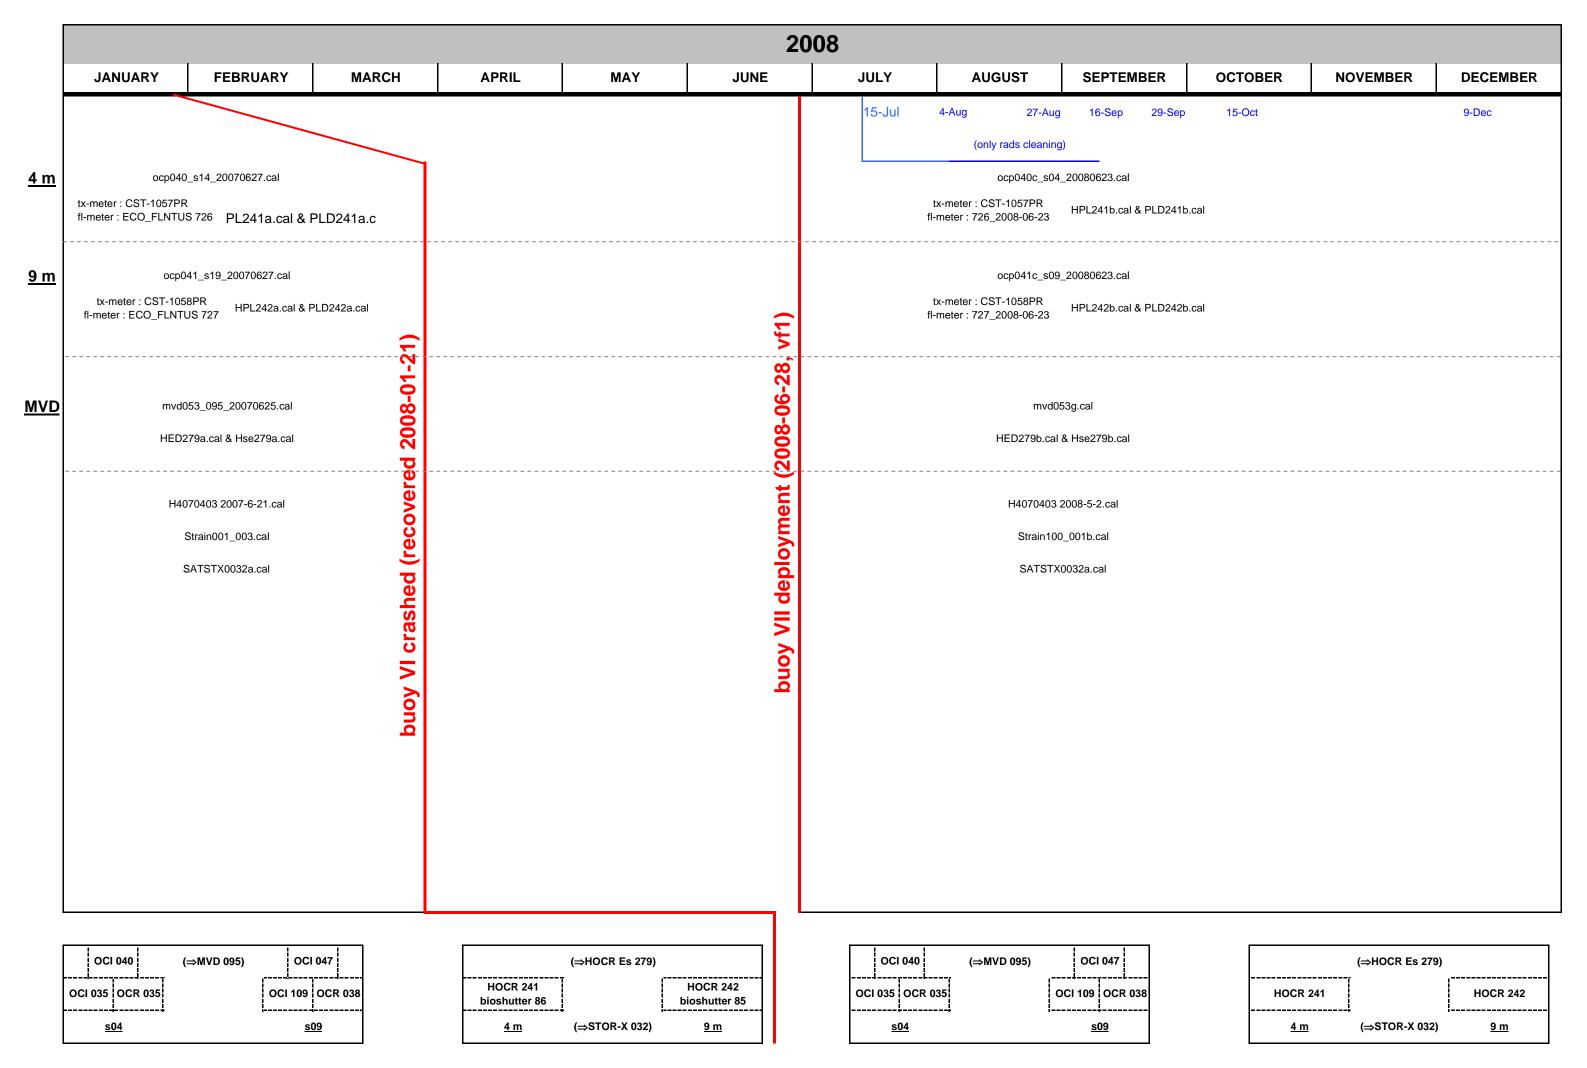
The following page contains the schema of the buoy and the list of the calibration files.

OCI 050			(⇒MVD 030)		OCI 164				
OCI	048	OCF	₹ 036		ОС	163	OCR	037	
	<u>s(</u>	04			,	<u>s</u> (	<u>09</u>

ocı	166		(⇒MVD 165)		ocı	168	
OCI	167	OCF	R 107		ОС	169	OCR	108
	<u>b</u> (	<u>04</u>		•		b	09

ocı	040		(⇒MVD 095)		ocı	047	
ocı	035	OCF	035		ocı	109	OCF	₹ 038
	<u>s</u>	14	<b>-</b>		<b>,-</b> -	<u>s</u>	<u>19</u>

HOCR 241 bioshutter 86		HOCR 242 bioshutter 85
<u>4 m</u>	(⇒STOR-X 032)	<u>9 m</u>
