The BOUSSOLE project technical reports; report #7-18, issue 1.

BOUSSOLE buoy deployment & maintenance log.

June 14, 2011 - March 14, 2014

BOUSSOLE project

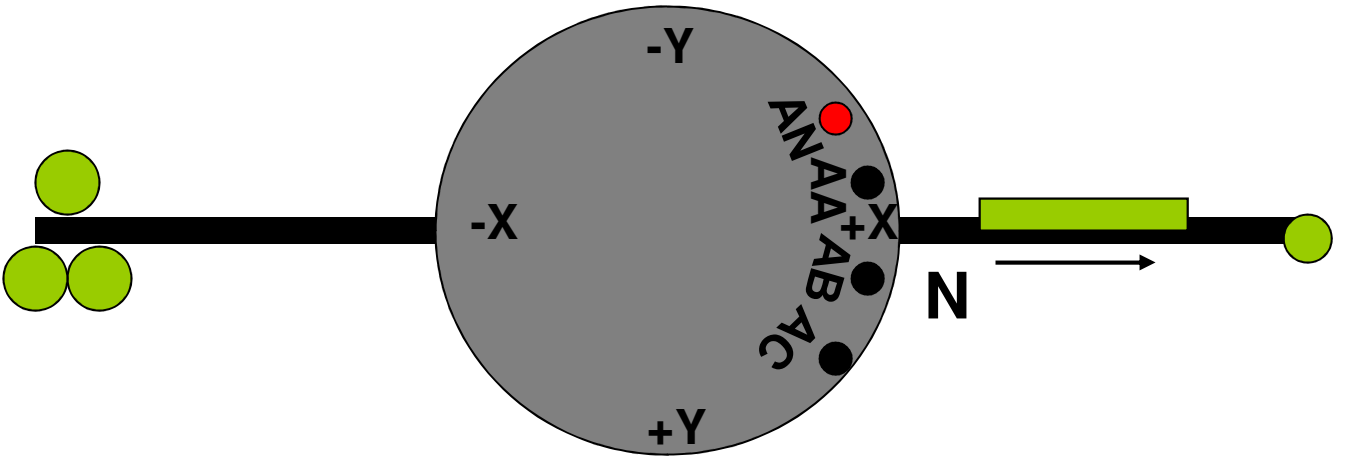
MVD (OCI) 095
 ARGOS 17152 (18797)
 Es (HOI) 279
 Junction Box SJB 004
 MVDS 053
 PAR 097

Feux:
 Solar Panels:

The following page contains the schema of the buoy and the list of the calibration files.
