BOUSSOLE Monthly Cruise Report

Cruise 36

October 15 – 19 (+23), 2004

BOUSSOLE project

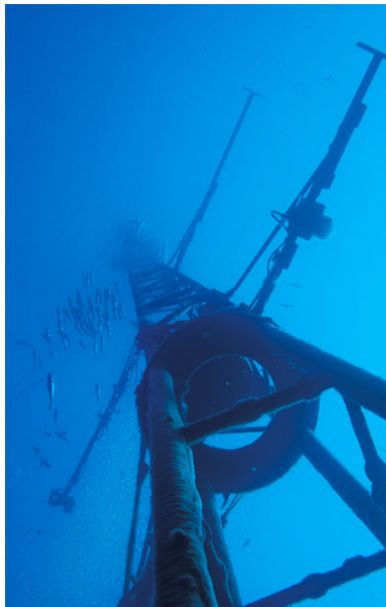
Fig 1. The buoy as seen from under the Sea surface (approx. -12 m).
