Full rotation of the BOUSSOLE buoy and mooring September 15-18, 2019

V. VELLUCCI

BOUSSOLE Project

September 30, 2019

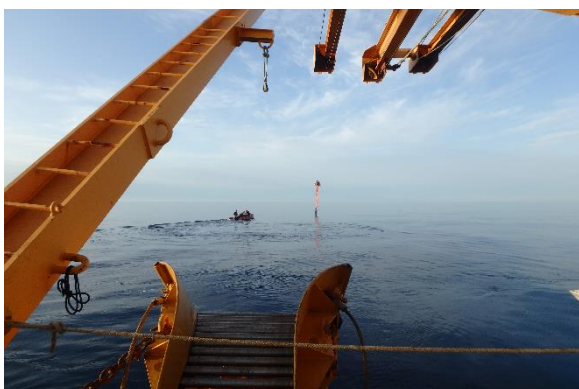
Pic. 3

- 07.05 Arrival at the BOUSSOLE site (43°22' N, 7°54' E). Weather conditions are pretty good. The buoy is not tilted, indicating no current (**Pic. 3**). Divers prepare to go at sea.

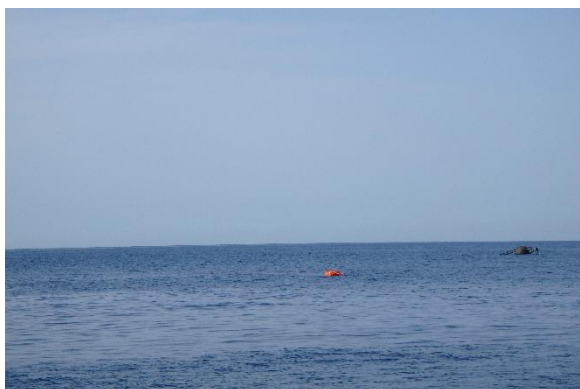
Pic. 7

- 10.29 Orange floats at surface (**Pic. 7**). Preparation to recover the mooring line.
- 10.40 The zodiac reaches the mooring line and brings it close to the ship for starting its recovery.

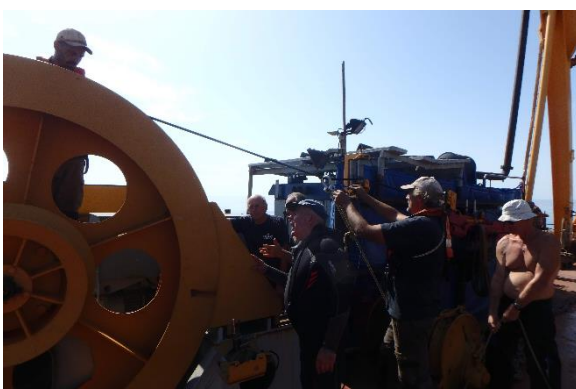
Pic. 10

- 10.50 Orange floats are onboard. A fishing line is tangled with them.
- 11.43 Start of the recovery of the Kevlar cable (**Pic. 10**). Operations will not be interrupted for lunch.

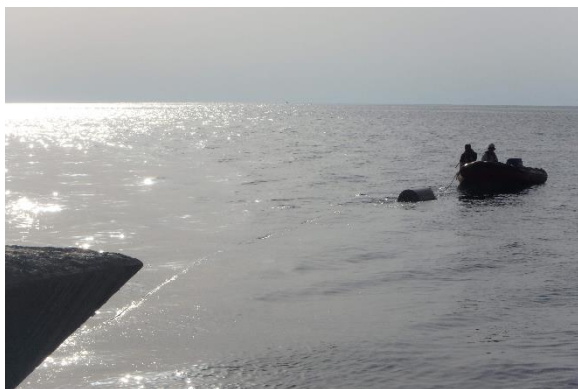
Pic. 18

- 17.28 The small (100 kg) float with the 70 m textile rope is deployed (**Pic. 18**). The zodiac is at sea and keeps the line away from the ship.
- 17.32 The big (630 kg) float is deployed with the 21 m chain (**Pic. 19**), soon after the Kevlar cable deployment starts.

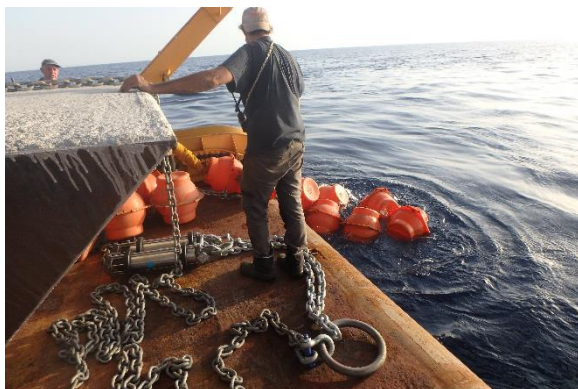
Pic. 23

- 18.30 The Kevlar cable is completely unwind, its lower termination is fixed to the chain.
- 18.35 The orange floatation spheres and acoustic releases are deployed (**Pic. 23**). The ship is at ~1 km from the release point.

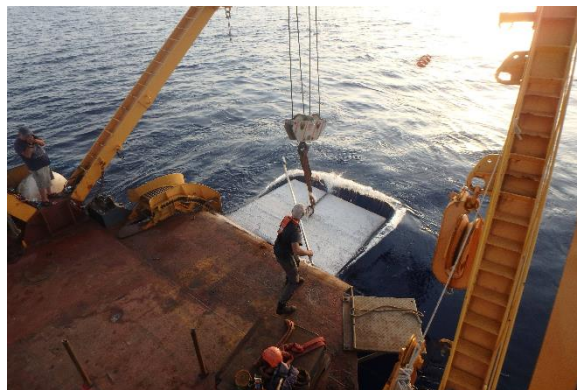
Pic. 26

- 18.57 The 4th support foot is cut off the ship deck the ship heads to the deployment point.
- 19.12 The sling is cut and the dead weight dives (**Pic. 26**).

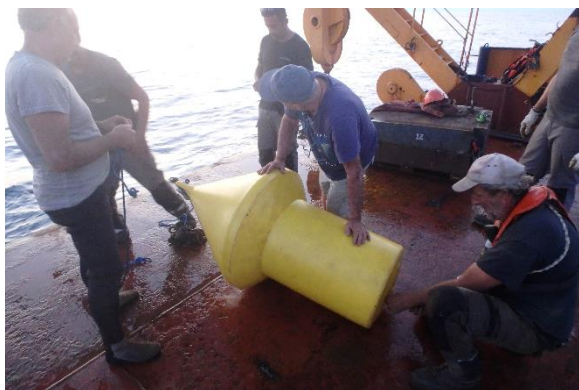
Pic. 27

- 19.25 The first inflatable boat is onboard.
- 19.45 A light buoy (**Pic. 27**) is attached to the mooring line for the night, and the 2nd inflatable boat is onboard. End of the first day operation and dinner.

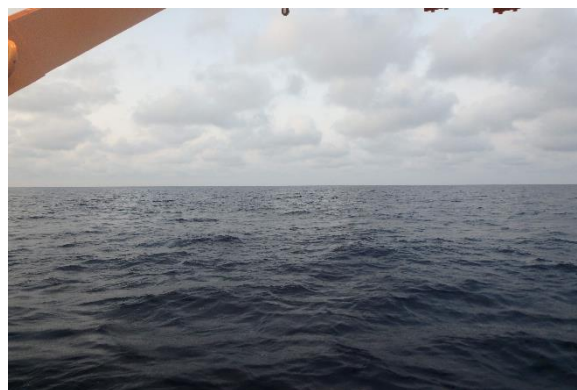
Pic. 28

- 06.30 Recovery of the operations. Meteorological conditions are good with moderate wind and swell (8 kn and 0.5 swell, **Pic. 28**).
- 06.50 The 100 kg float is recovered on board and the line is kept with the port winch through the 70 m textile rope.

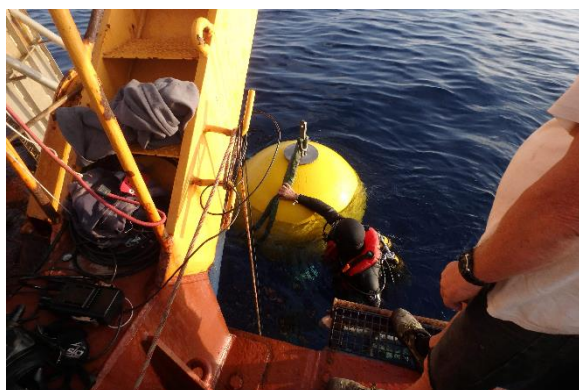
Pic. 29

- 07.24 The 630 kg float is at surface (**Pic. 29**) and loaded onto the ship. Divers on board.
- 07.40 Divers at sea to attach the line to the biggest winch with the synthetic rope.

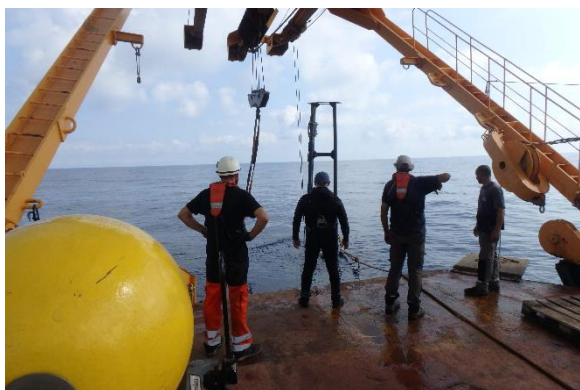
Pic. 35

- 11.03 The structure is at sea, divers go again at sea (**Pic. 35**).
- 11.10 The lower superstructure is completely underwater. The upper part of the sphere is clearly visible from the surface (**Pic. 36**). The upper part of the buoy is at 8.20, it is decided not to lower further the structure.

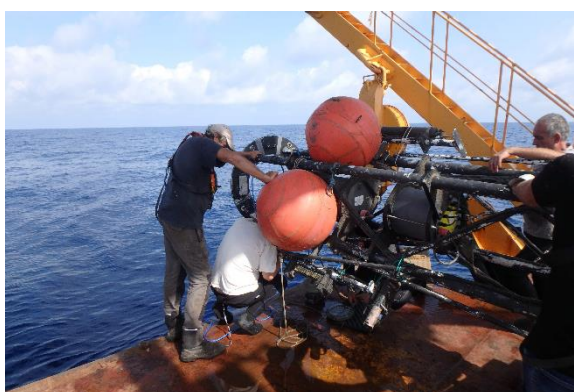
Pic. 38

- 14.15 Floats and leads are mounted on the instrumented mast for ballasting (**Pic. 38**).
- 15.00 The instrumented mast is deployed (**Pic. 38**), and divers go at sea to mount it upon the lower superstructure.

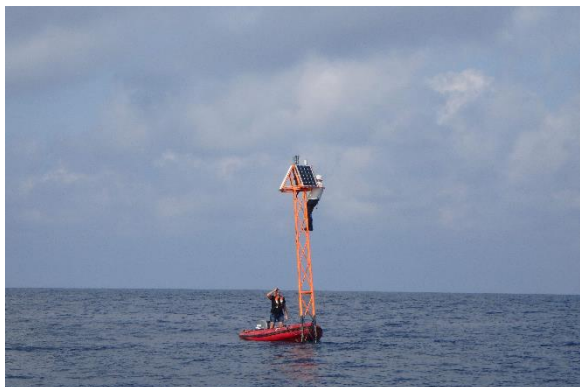
Pic. 41

- 16.15 The buoy battery and the Junction box are switched on (**Pic. 41**).
- 16.20 The recovered lower superstructure is brought on board (**Pic. 42**).
